**12 Month Report:**  
**Intelligent Bolt Trials for Fishplates & Temporary Clamps**

| Project: | E0102 v3 |
| Document ref: | 12 Month Report -<br>December 2024 |

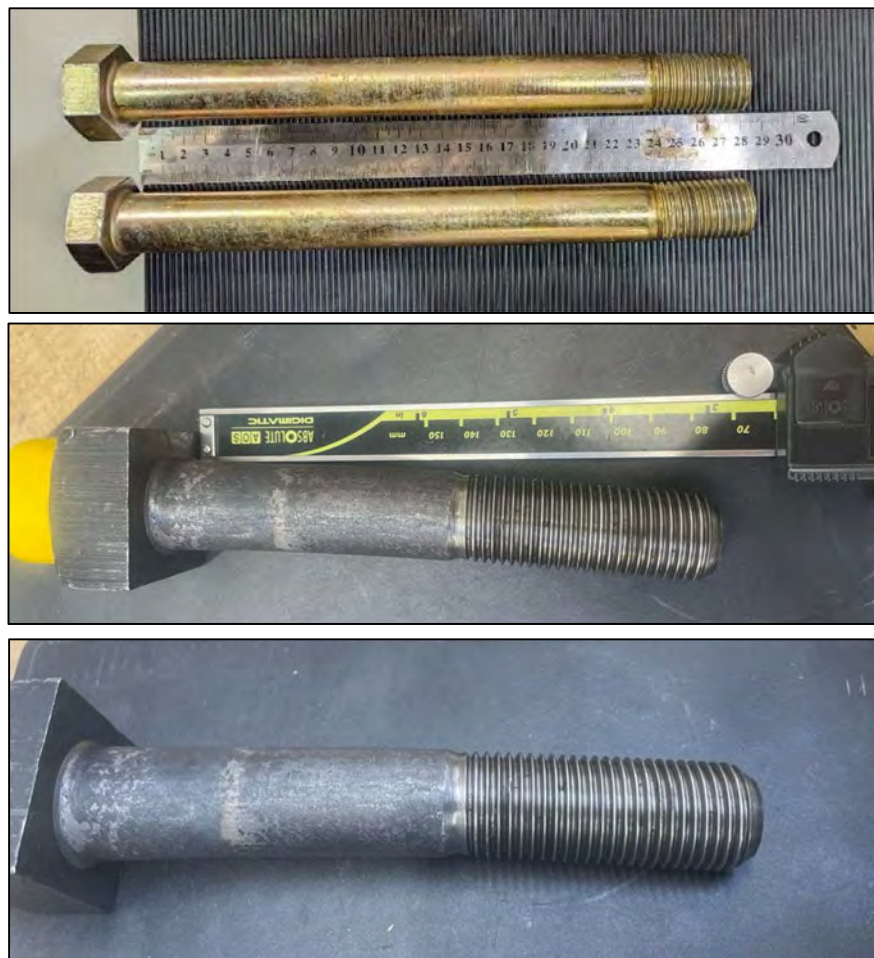
During the conversion of bolts supplied by either Network Rail or the clamp supplier, significant failures were recorded. There was a failure rate on an average of 20% on fishplate bolts. This increased significantly to a failure rate above 50% when converting bolts for use in temporary clamps.

*Images show failed bolts under load test.*

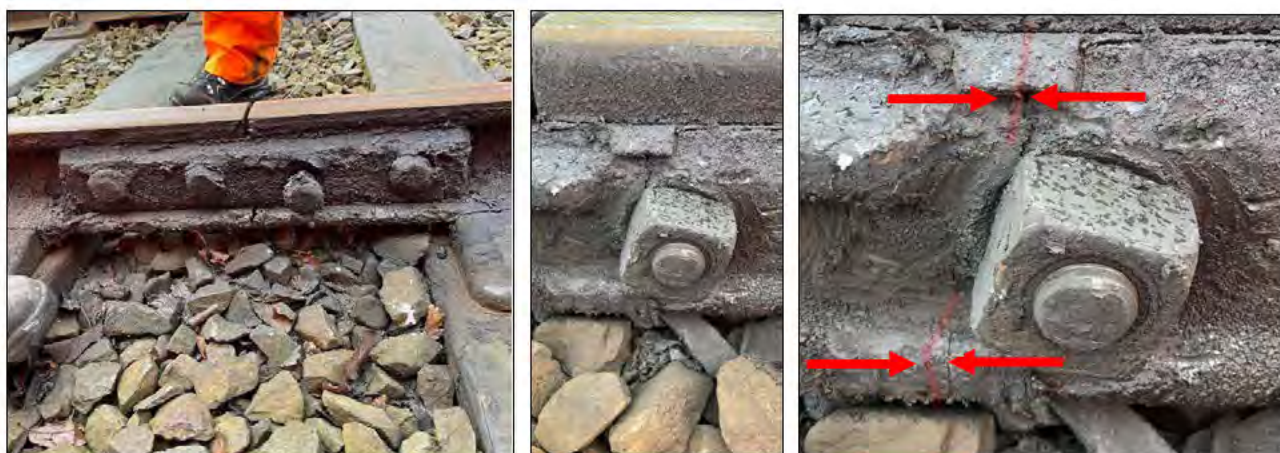
**Traditional grease**

Although the number of cracked fishplates is not consistently or rigorously reported across the network, it remains a very common issue. The current maintenance method, which involves applying a thick layer of black grease, often conceals cracks of any size or depth. These cracks remain undetected until the fishplate eventually fails and separates into two pieces.

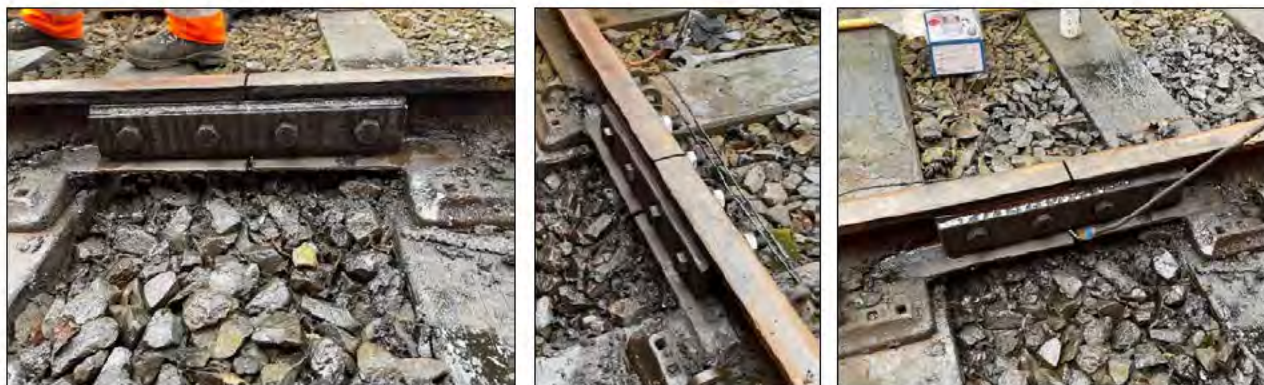
**Interflon Lube EP**

In contrast, Interflon Lube EP is transparent, and while switching lubrication materials will not directly prevent failure, it will allow any potential defects to be identified much earlier. This proactive approach facilitates the early detection of cracks, enabling the timely removal and replacement of failed joints with new plates before further damage occurs.

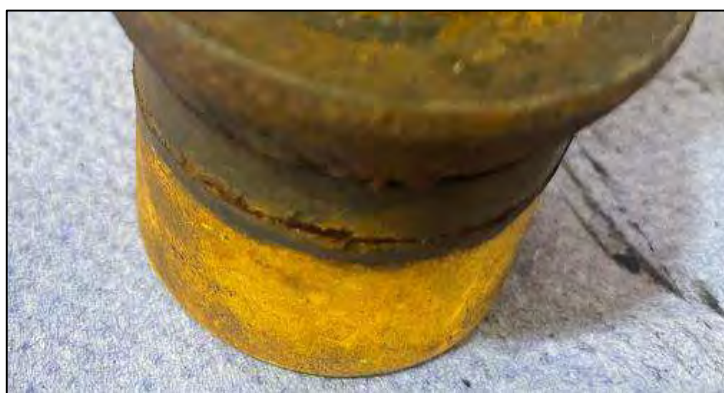
*Bolt corrosion leading to seal failure and moisture ingress*

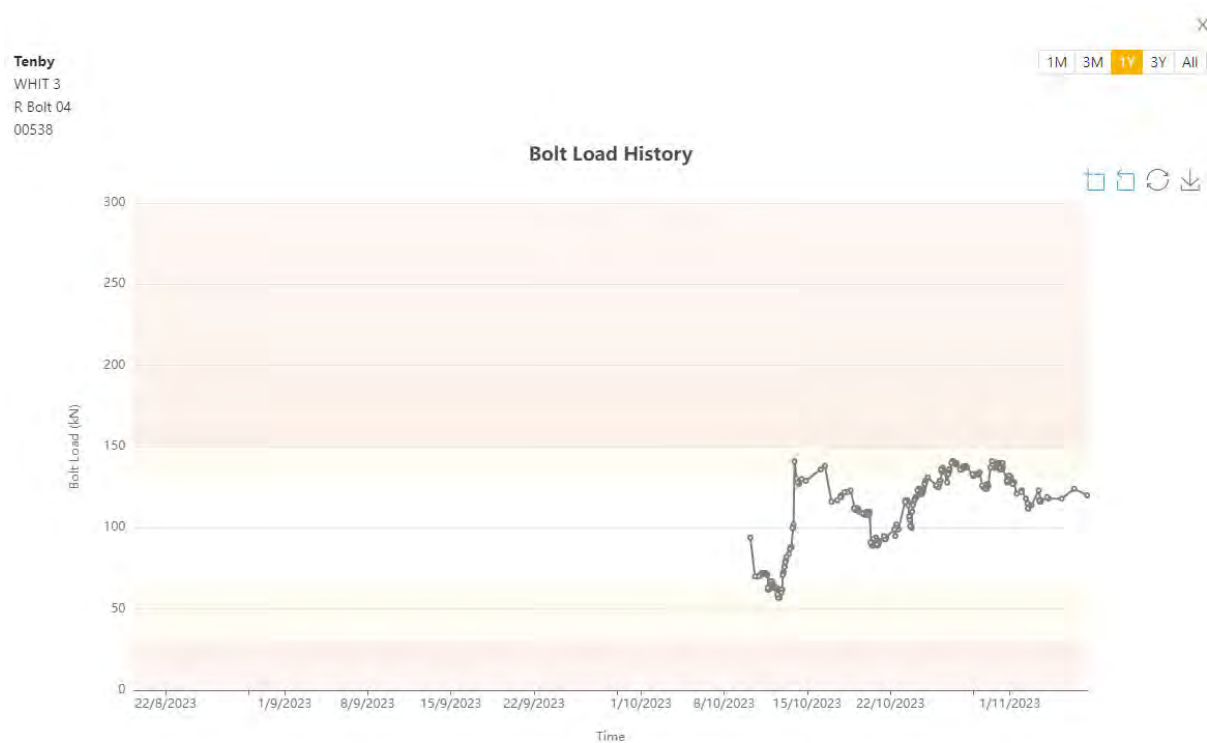
The change in bolt load over time of some of the imperial fasteners is highly unpredictable. An example of this is ID 00538 (WHIT 2), see Figure 2 below.

Figure 2. Bolt load over time of imperial bolt 00538.

In Figure 2 it can be seen that the bolt load fluctuates quite significantly over time. This is believed to be a result of the under-head condition of the PEAR headed bolts (see picture of PEAR headed bolt below). Since there are prominent high points on the underside of the bolt head, when the fishplate slides, the load being surface changes so the bolt will see a fluctuation in bolt load (low point = reduce bolt load, high point = increase bolt load).

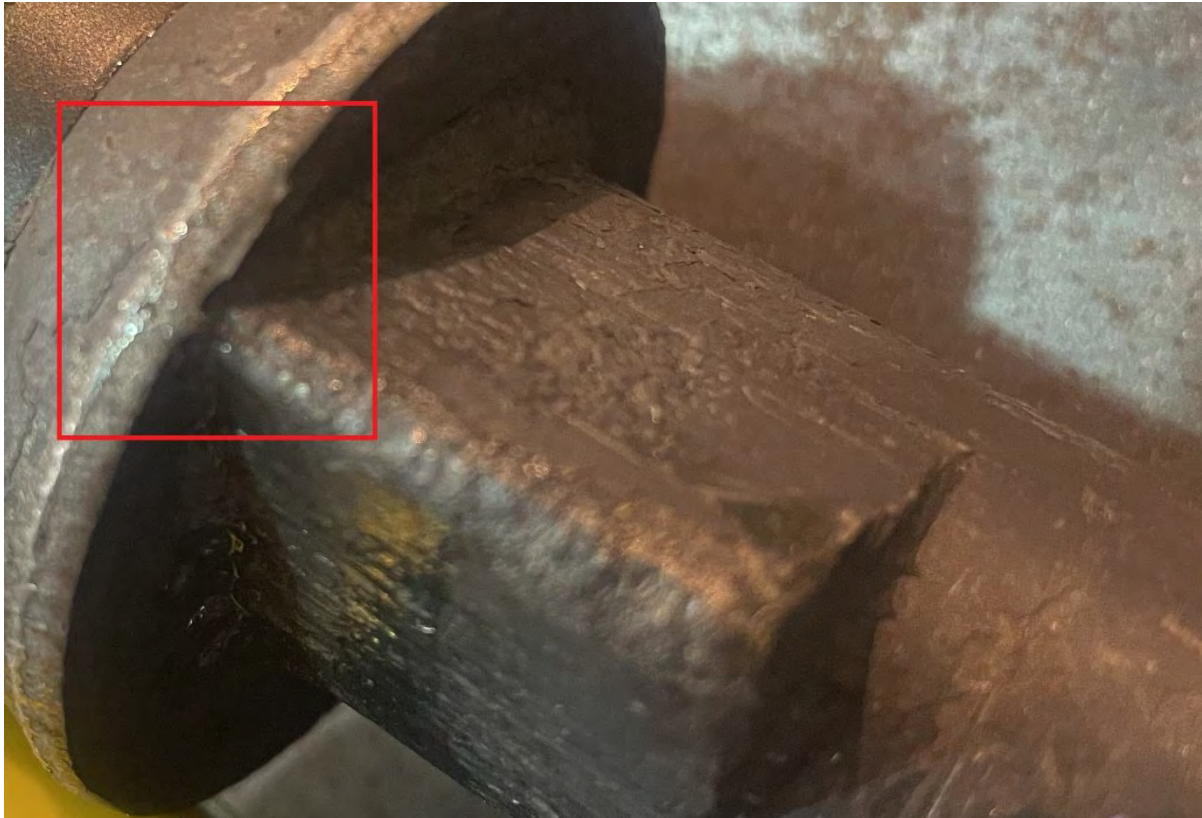
*Figure 3. Under-head condition of PEAR headed bolt.*

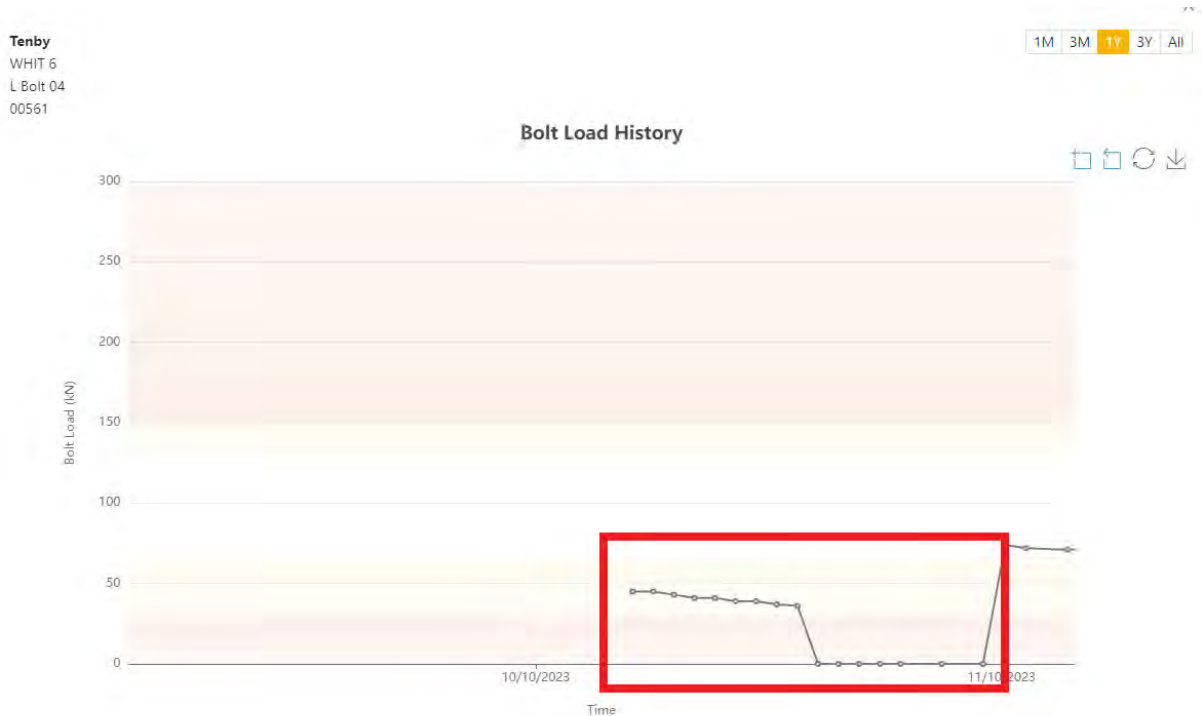
- 1) Both bolts on WHIT 6 reported a complete loss of bolt load after 12 hrs of operation (see Figure 6). An inspection that evening found that the fishplate hadn't been correctly seated. Since the bolts were retightened, no further drop in bolt load has been observed. If the bolts are tightened to a higher bolt load and a second pass is conducted, this may help seat the fishplate and could prevent this from occurring.

Figure 6. Bolt load over time for metric bolt 00561.

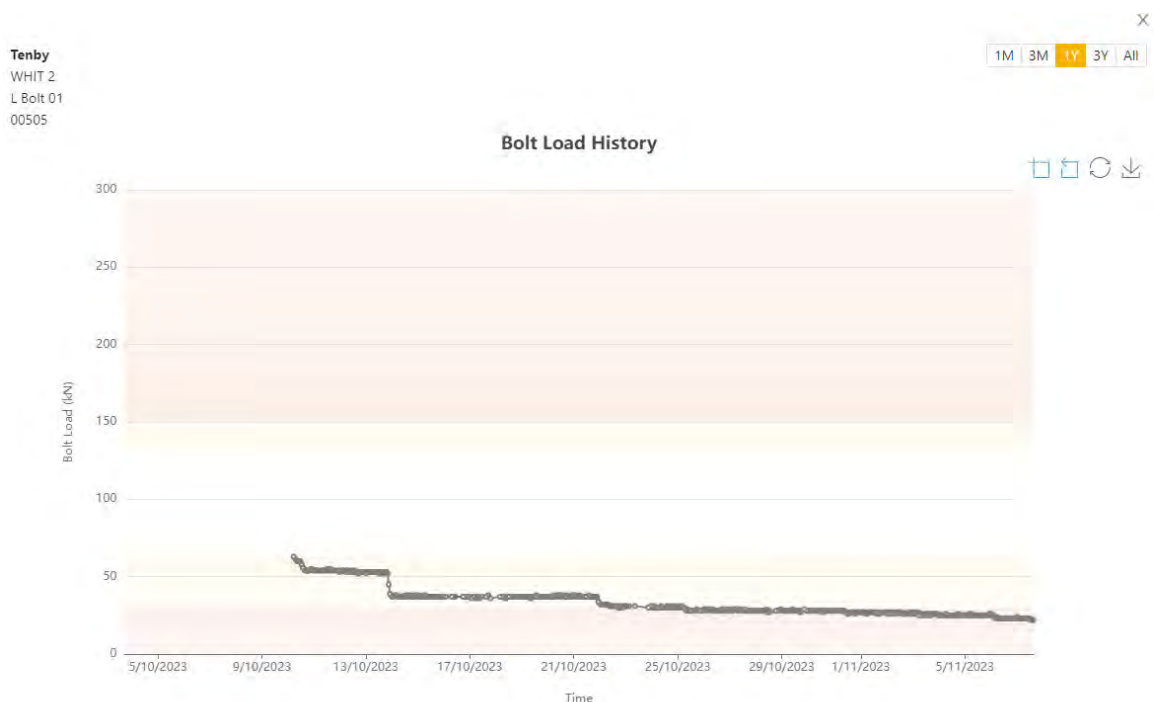
- 2) Some bolts are reporting a gradual decline in bolt load over time (see Figure 7). This is likely to be a result of low bolt leading to the bolted connection seeing a greater amount of the dynamic loading. This in turn will exacerbate vibration induced loosening. If the bolt has a higher bolt load, it is likely that the severity of this would be significantly reduced. The average bolt load of metric bolts after settling and embedding losses were taken into account was 39kN which is around half that expected for the application.

Figure 7. Bolt load over time for metric bolt 00505.

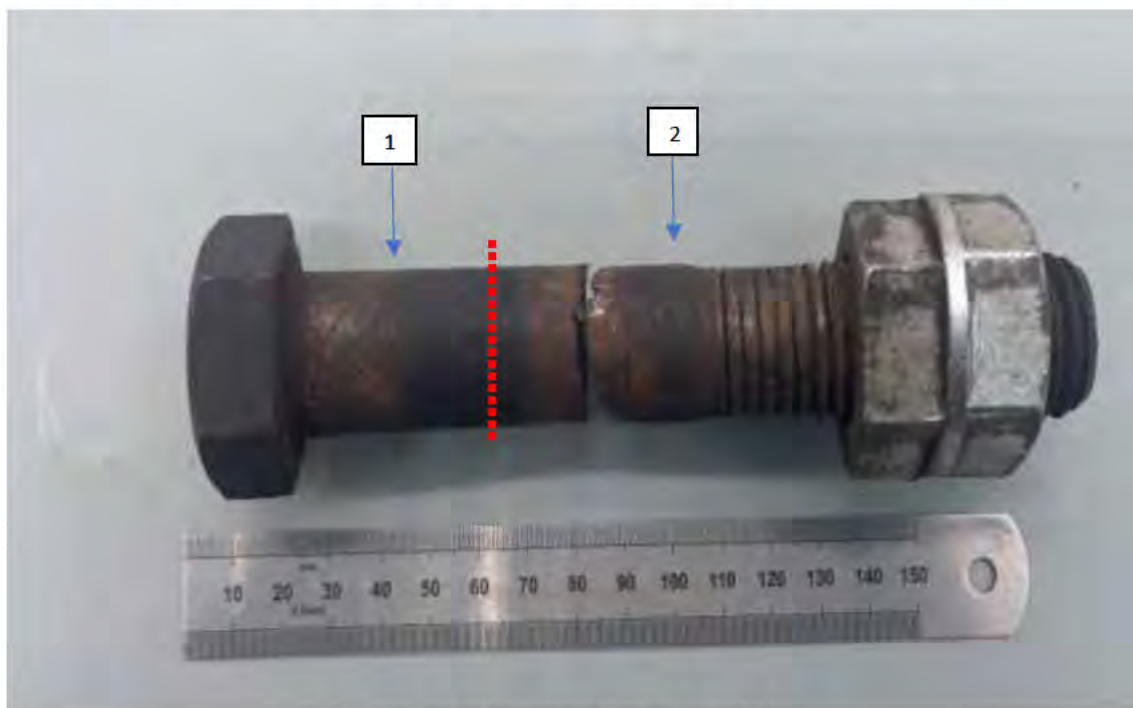
R-TECH Consultants Ltd received a failed M24 fish bolt from Staytite Ltd with a request to determine the cause of failure. It was advised that the bolt had been in service for 18 months and had failed under normal operational parameters. The bolt was advised as being M24 class property 8.8 and as such was composed of a medium carbon steel in the quenched and tempered heat treatment condition. R-TECH were informed that the bolt was mechanically fixed through a rail, which was in turn sandwiched between two fish plates. The bolt was received in two halves and identified by R-TECH as 1 and 2, Figure 1.1. For the ease of examination, the fracture surface of section 1 was removed in accordance with the red-dashed line in Figure 1.1.

Figure 1.1. As-received image of the bolt

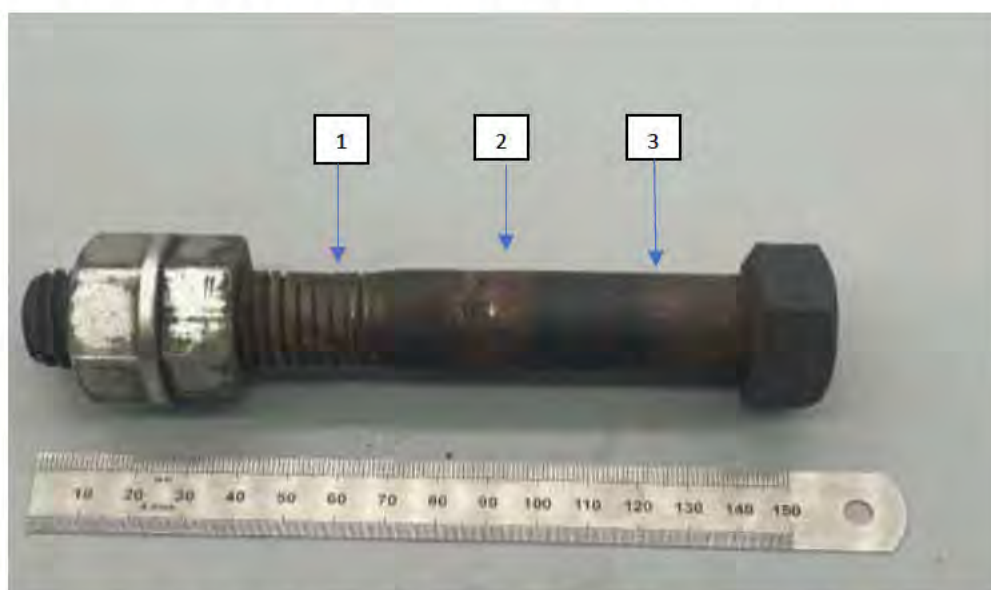
**Figure 2.1. Image detailing fish bolt: note damage to threads.**

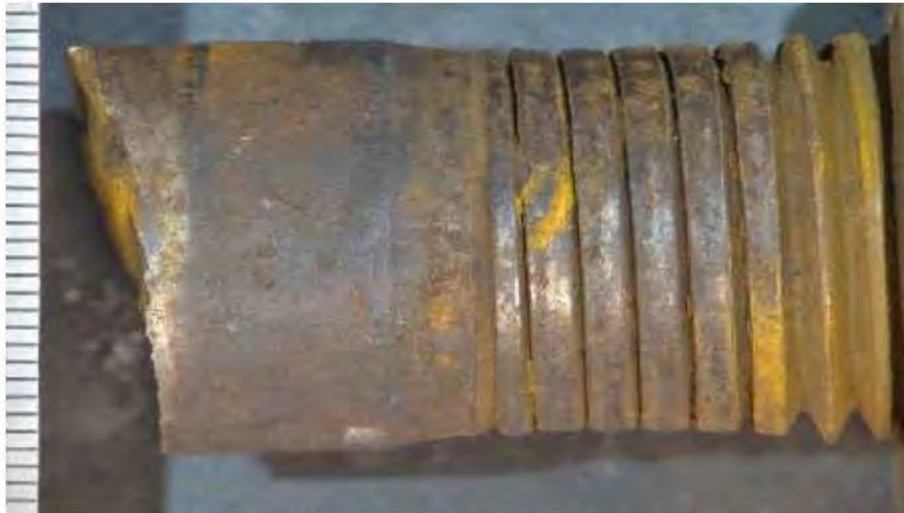
Figure 2.2. Image side 2 of bolt: Not damage to threads where the bolt was fixed through a fish plate. Note also an orange/brown deposit.

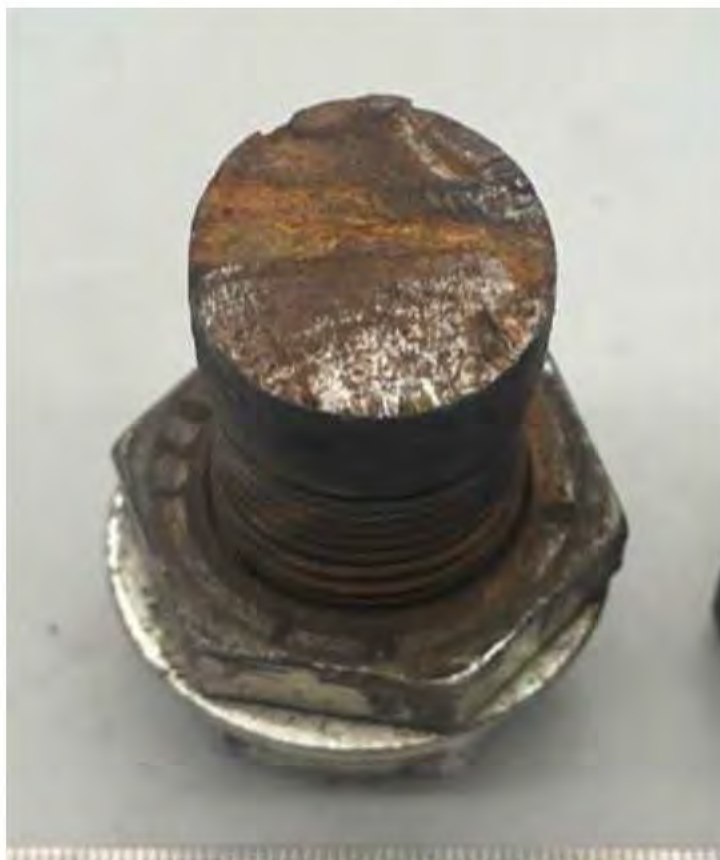
Figure 2.3. Image detailing fracture surface of side 2. Note the presence of an orange/brown coloured deposit across the surface.

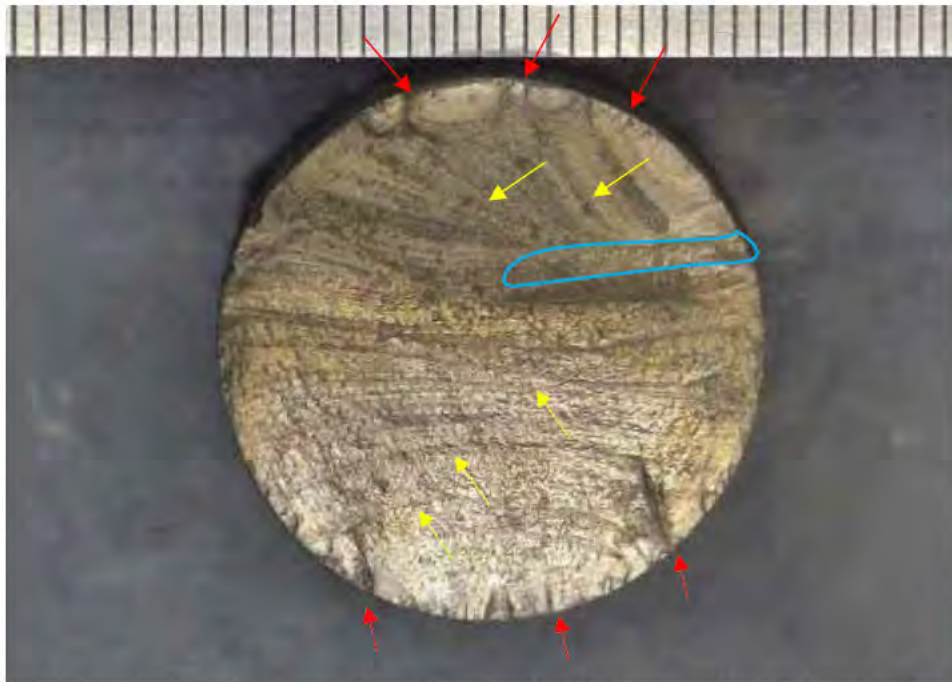
Figure 2.4. Image detailing fracture surface after cleaning. Note areas of ratchet marks diametrically opposed (red arrows), beach marks (yellow arrows) and final fracture (blue line).

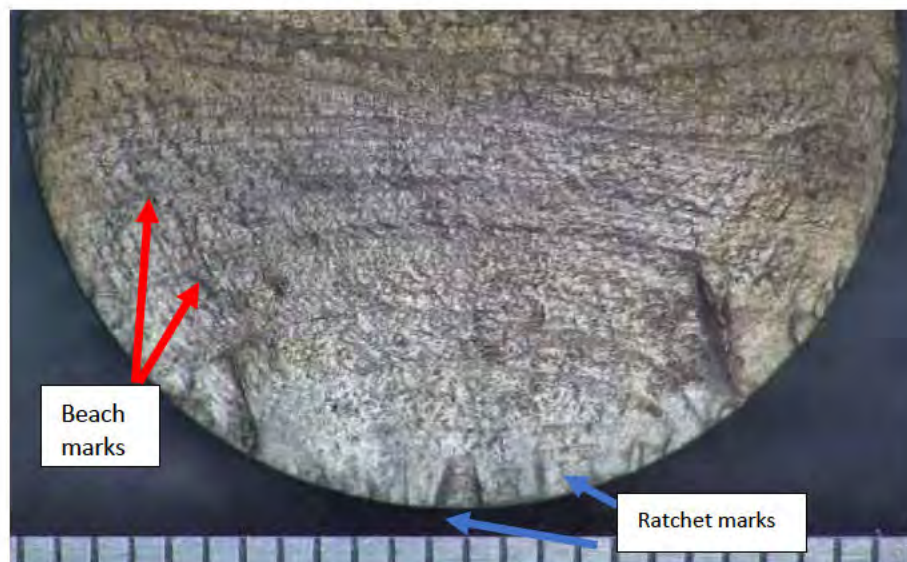
Figure 2.5. Image detailing fracture surface after cleaning. Note ratchet marks associated with larger fatigue crack located at the lower region of the fracture surface. Also note the presence of beach marks.

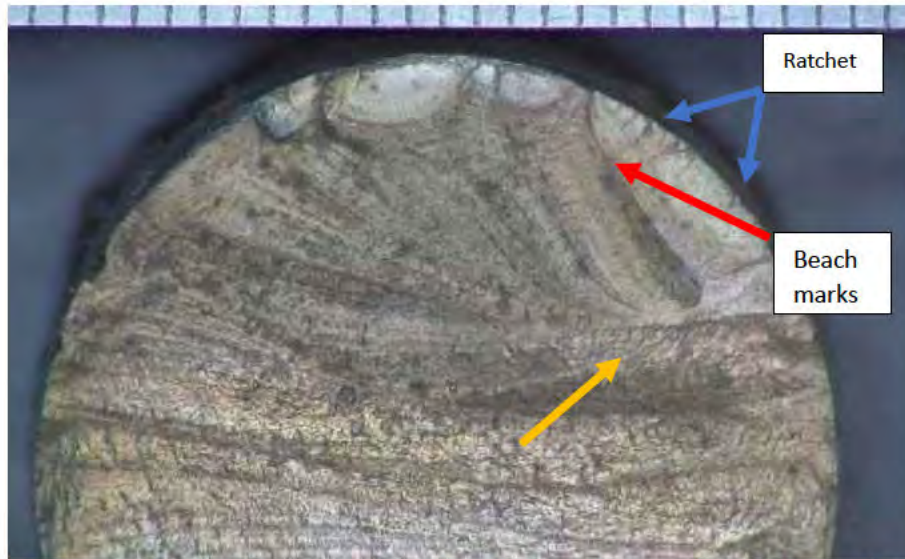
Figure 2.6. Image detailing fracture surface after cleaning. Note ratchet marks associated with smaller fatigue crack located at the upper region of the fracture surface. Also note the presence of beach marks and the final fracture area (yellow arrow)

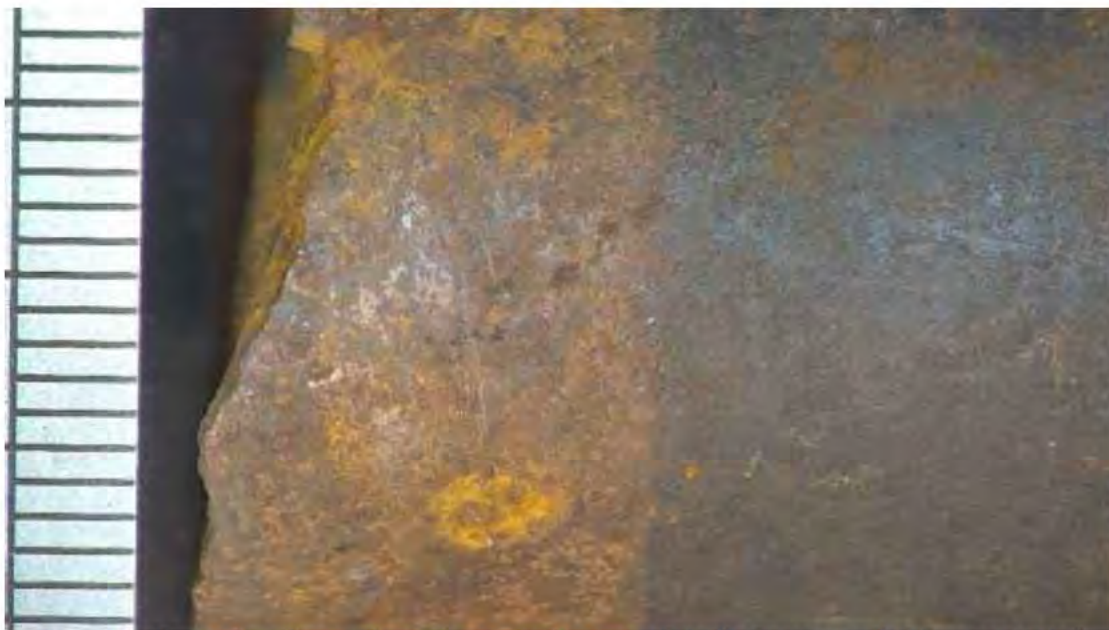
The surface adjacent to the fracture was associated with pitting and a corrosion deposit, Figure 2.7. This was analysed by Scanning Electron Microscopy/Energy Dispersive X-ray analysis (SEM/EDX), see later in section 5. Figure 2.8 details the presence of a small secondary crack just behind the fracture surface.

Figure 2.7. Image detailing surface adjacent to fracture. Note the presence of pitting associated with a corrosion deposit.

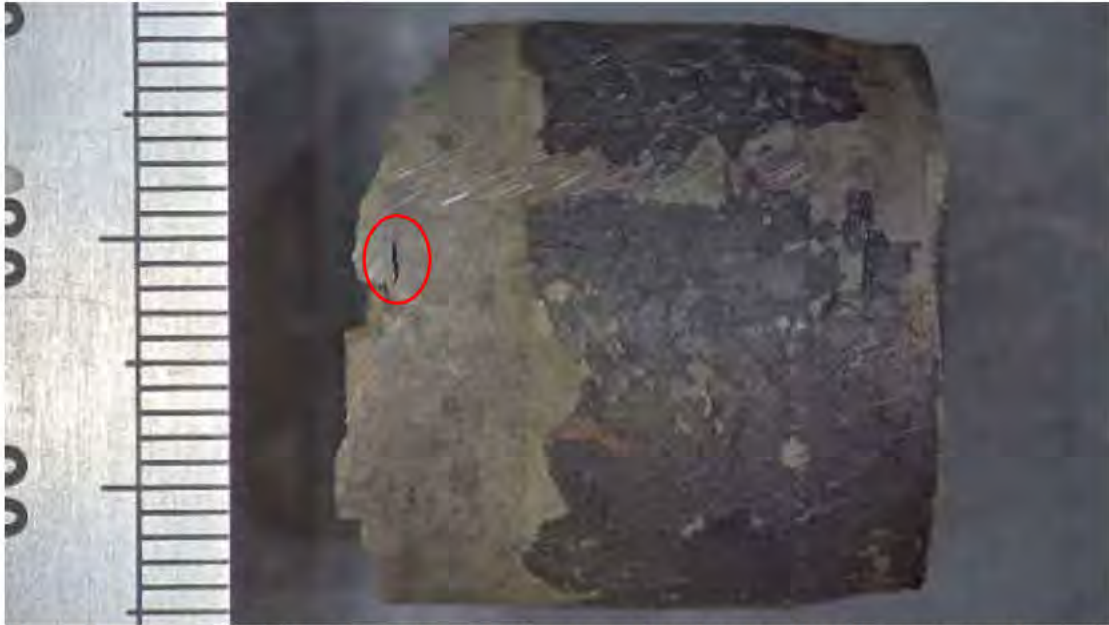
Figure 2.8. Image detailing surface adjacent to fracture, after cleaning. Note the presence of a small secondary crack (red circle).

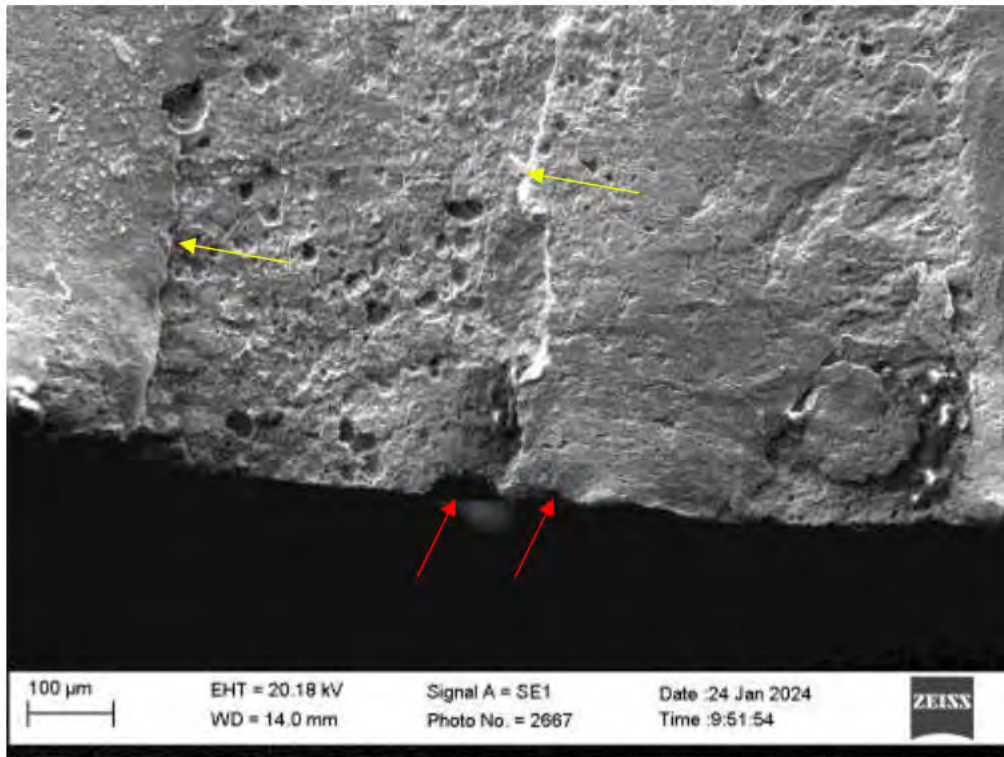
The ratchet marks observed are shown in more detail in Figures 4.1 to 4.3. In some instances, pitting was associated with the ratchet marks observed. The main fatigue fracture areas exhibited striations across the surface, Figures 4.4 to 4.8. The final fracture area exhibited micro-void coalescence, which is indicative of a ductile fracture mechanism, Figure 4.9.

Figure 4.1. SEM image detailing ratchet marks (yellow arrows) associated with major fatigue crack. Note the presence of pits along the surface (red arrows).

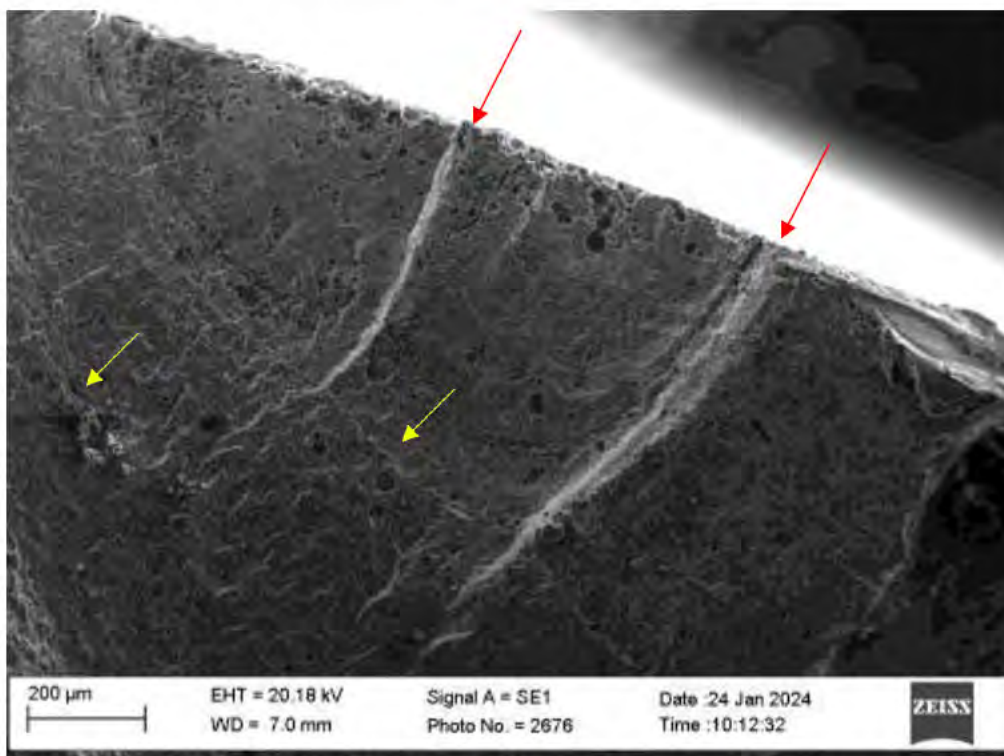
Figure 4.2. SEM image detailing ratchet marks (red arrows) associated with minor fatigue crack and beach marks (yellow arrows).

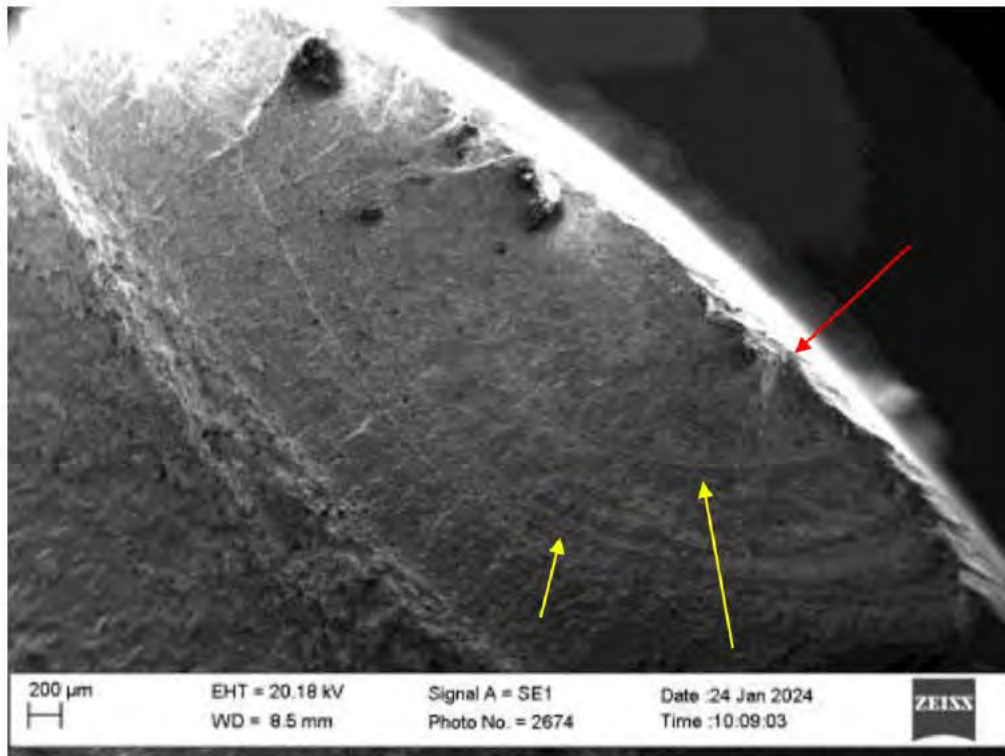
Figure 4.3. SEM image detailing ratchet marks (red arrows) associated with minor fatigue crack and beach marks (yellow arrows).

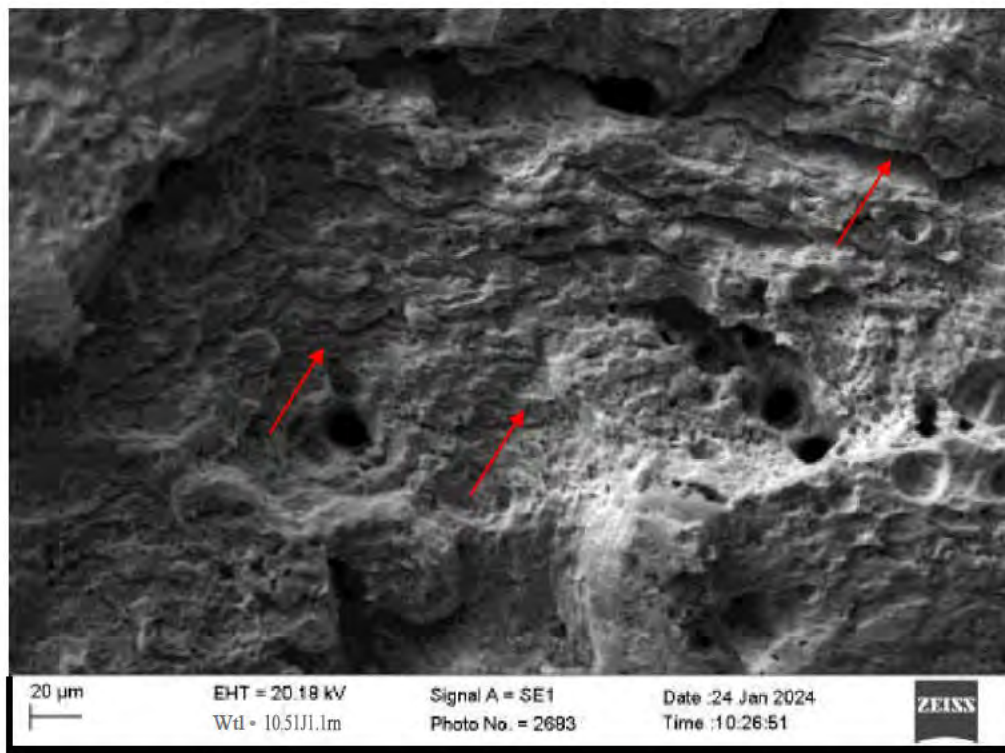
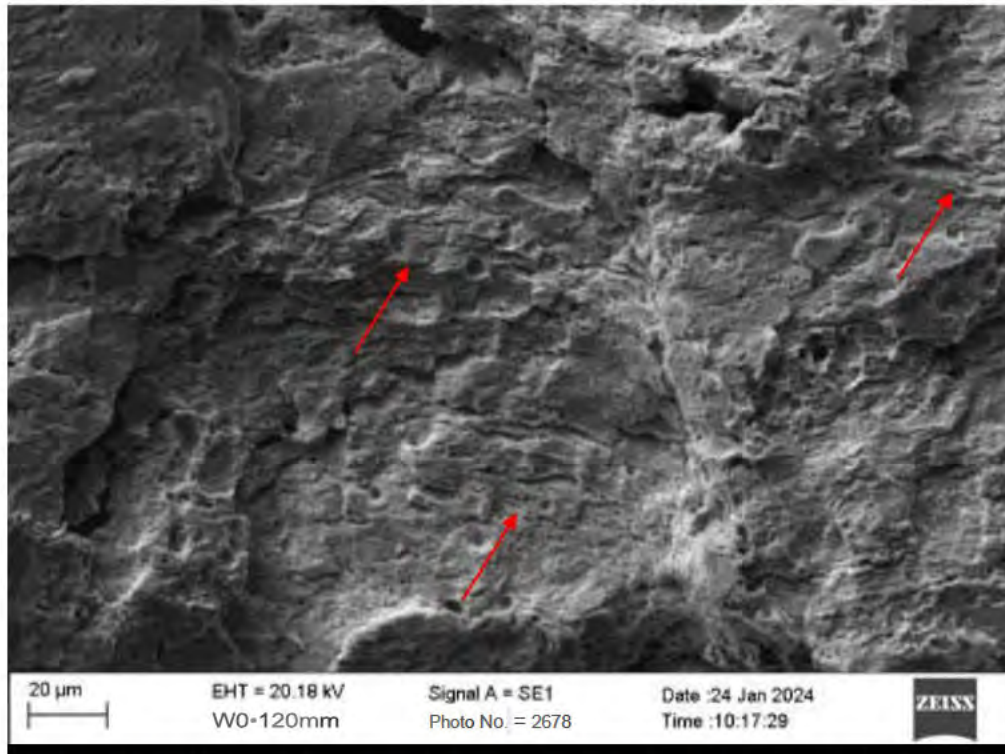
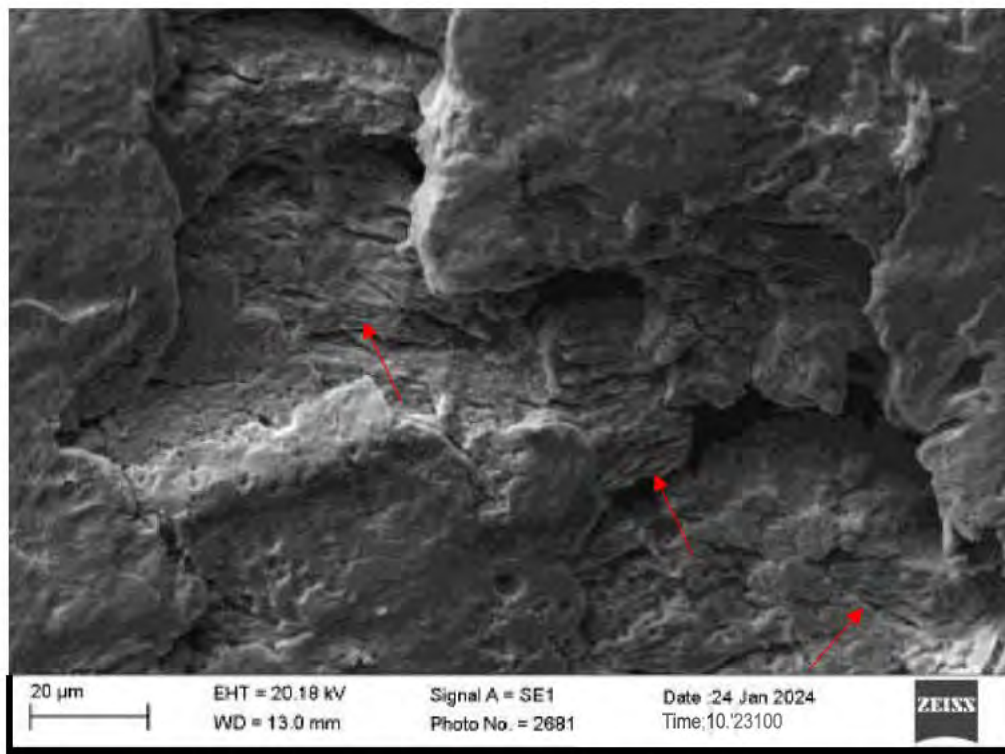
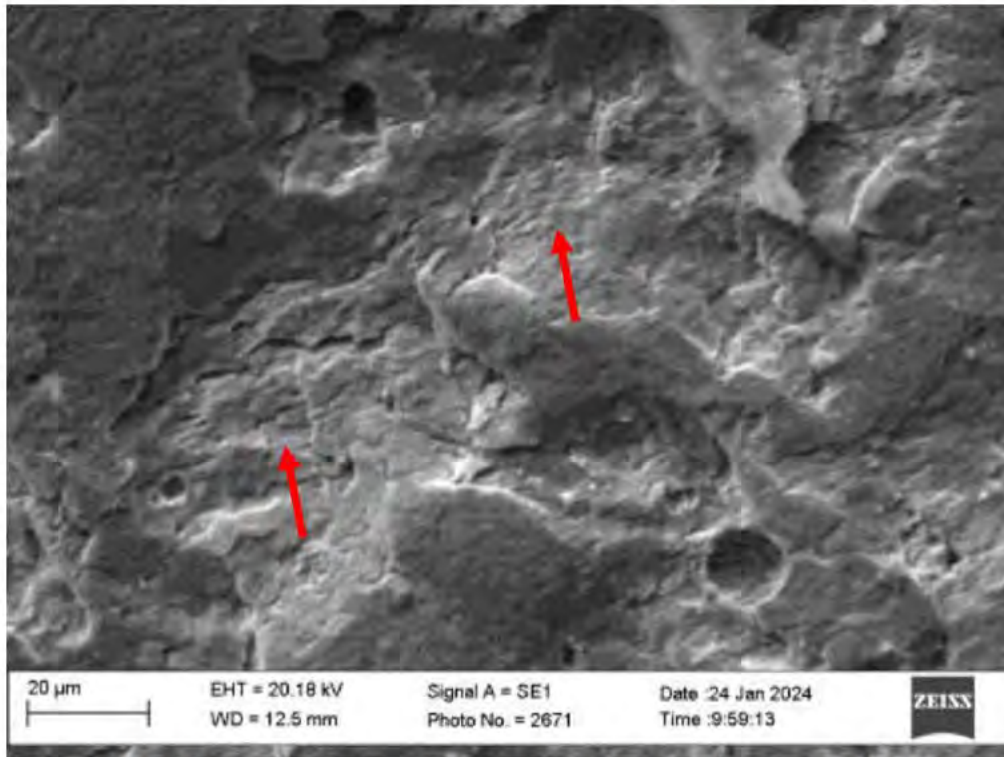
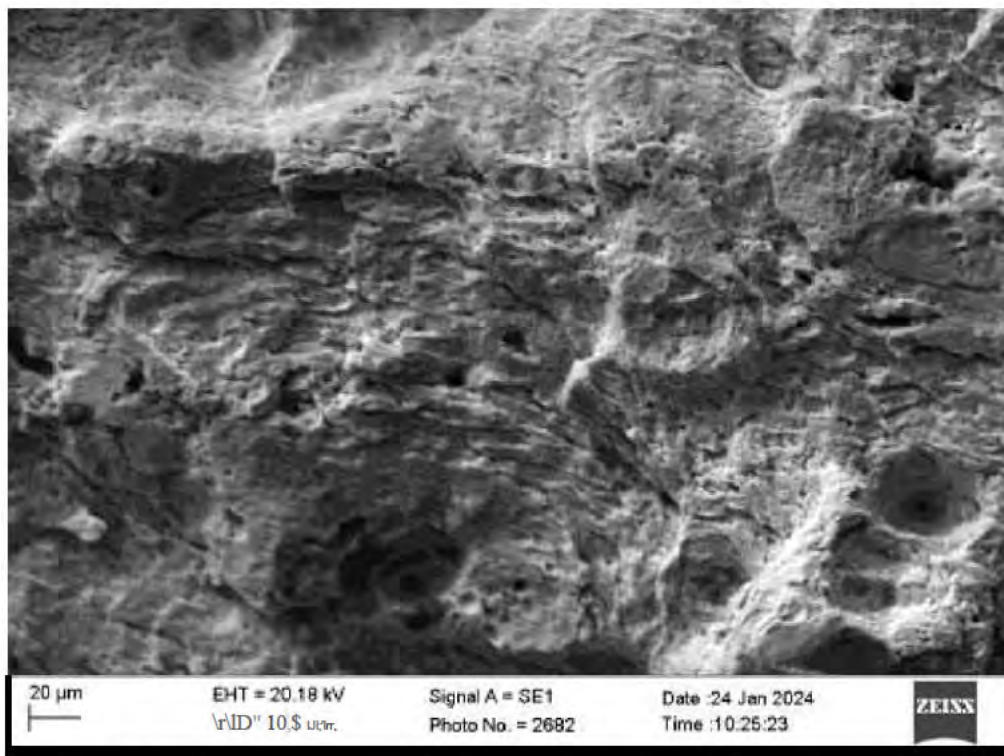
Figure 4.4. SEM image detailing main fracture surface. Note the presence of striations.

Figure 4.5. SEM image detailing main fracture surface. Note the presence of striations.

Figure 4.6. SEM image detailing main fracture surface. Note the presence of striations.

Figure 4.7. SEM image detailing main fracture surface. Note the presence of striations.

Figure 4.8. SEM image detailing main fracture surface. Note the presence of striations.

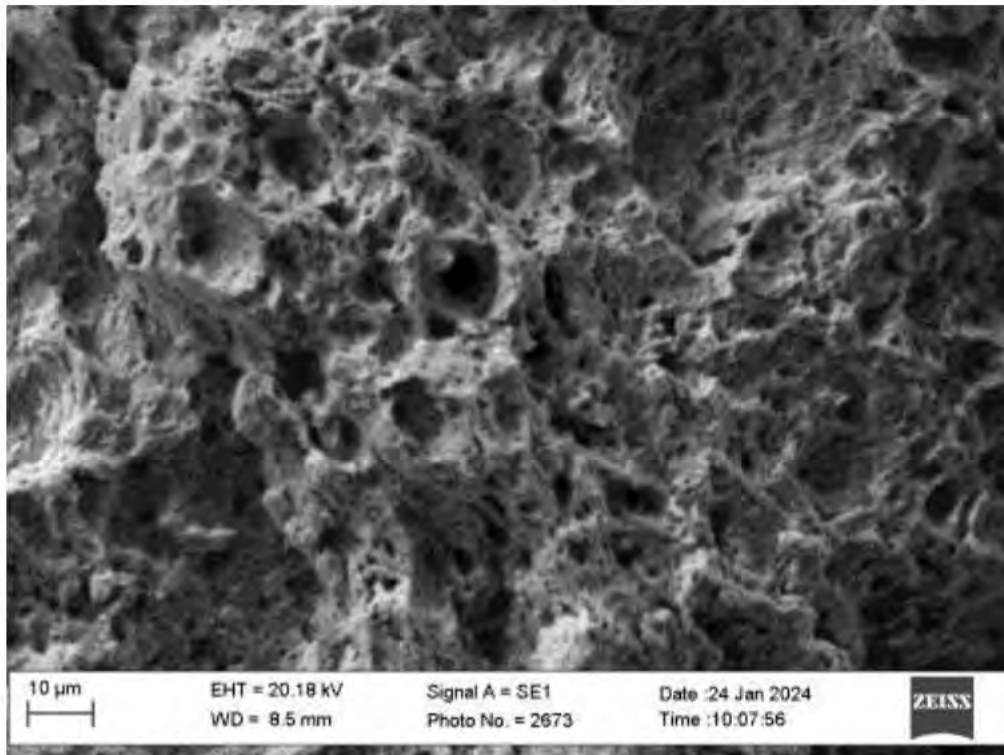
Figure 4.9. SEM image detailing final fracture region with micro-void coalescence evident.

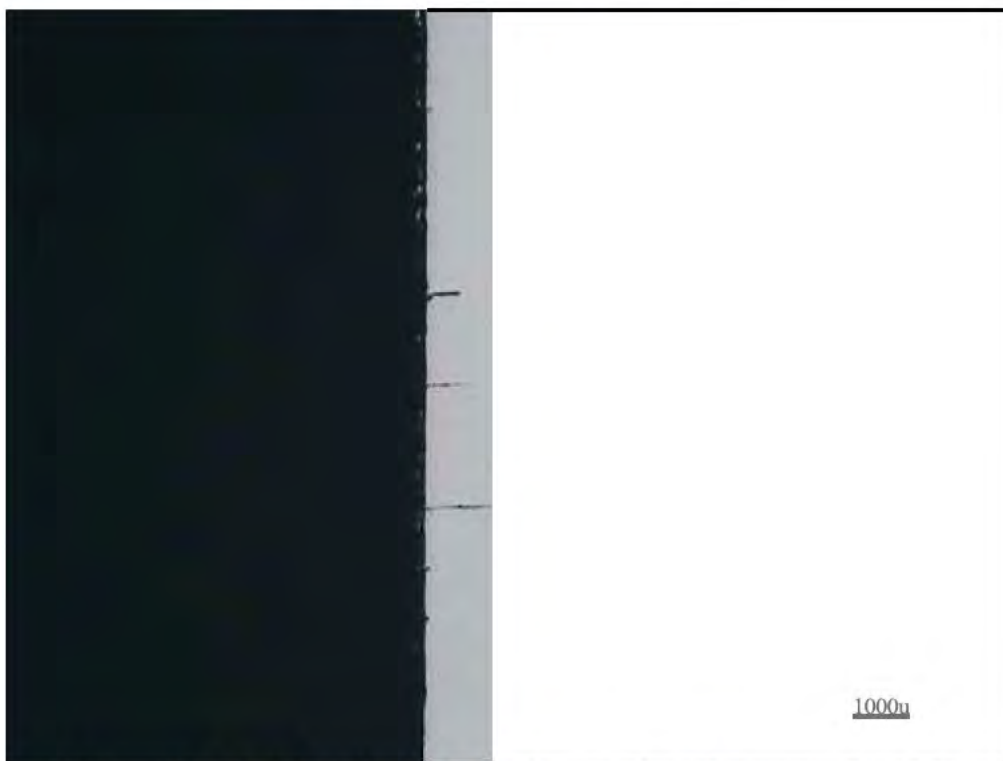
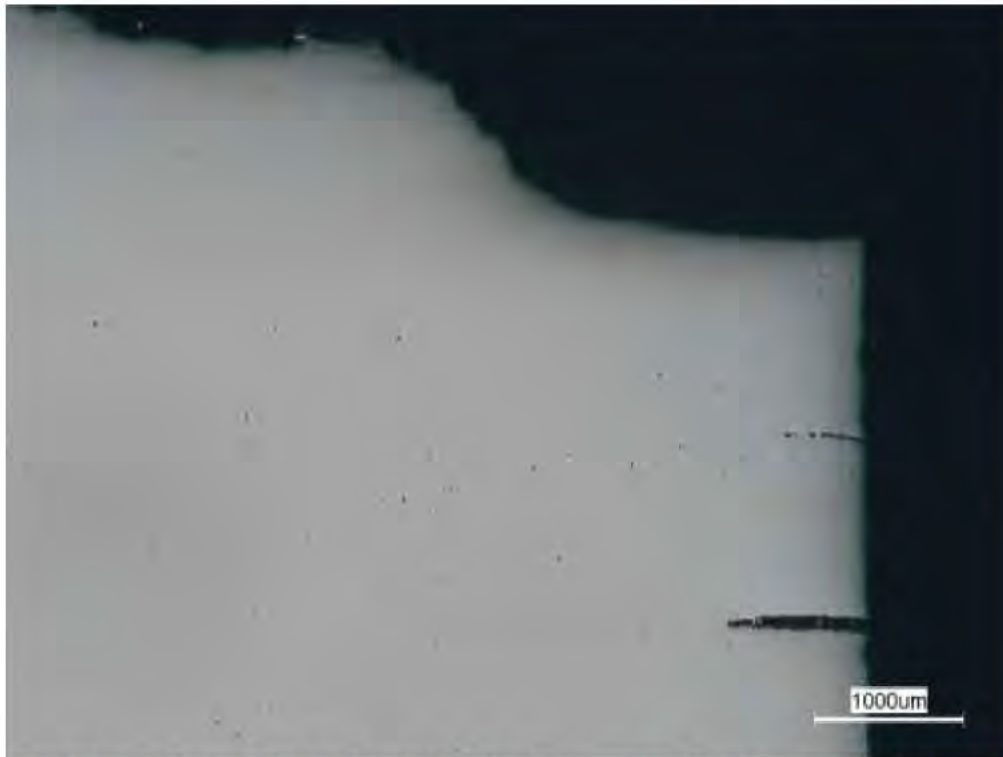
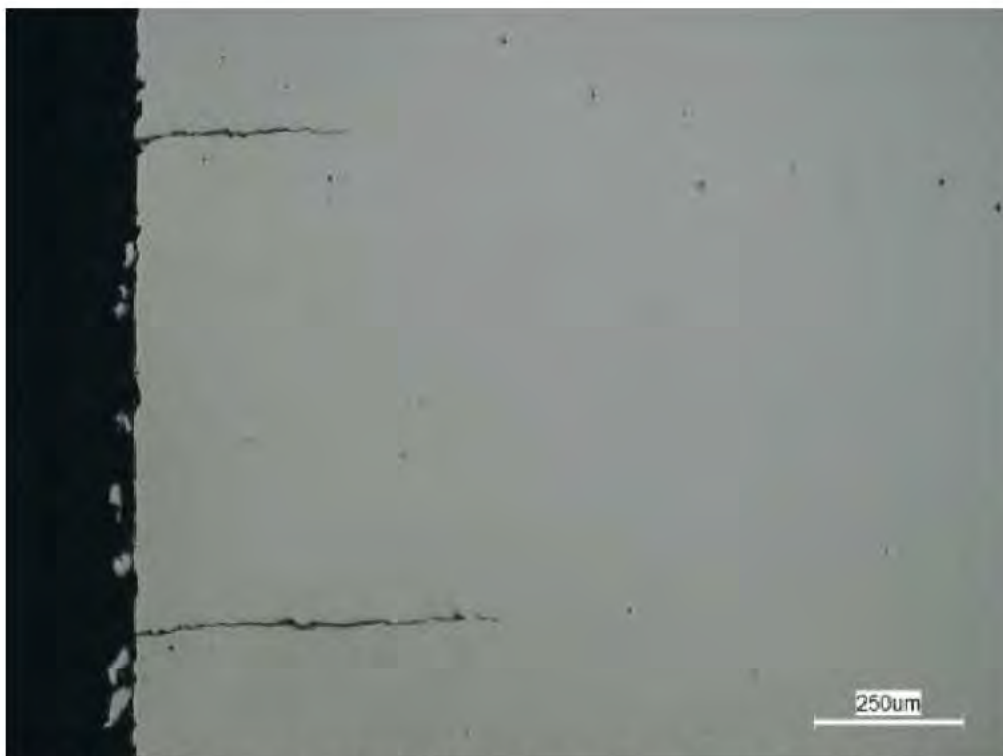
Figure 3.2. Image detailing bolt surface behind the fracture. Note the presence of multiple cracks.

Figure 3.3. Image detailing bolt surface behind the fracture. Note the presence of multiple cracks.

Figure 3.4. Image detailing bolt surface behind the fracture. Note the presence of multiple cracks.

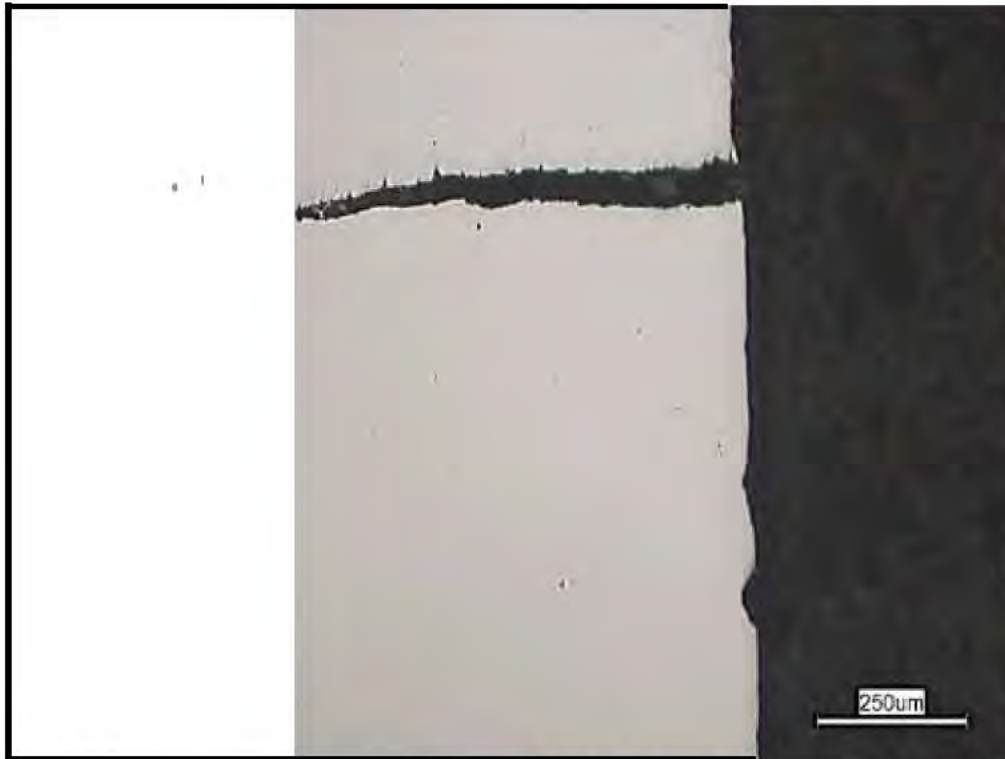
Figure 3.5. Image detailing bolt surface behind the fracture. Note the presence of a “spear-like” crack.
