**12 Month Report:**  
**Intelligent Bolt Trials for Fishplates & Temporary Clamps**

| Project: | E0102 v3 |
| Document ref: | 12 Month Report -<br>December 2024 |

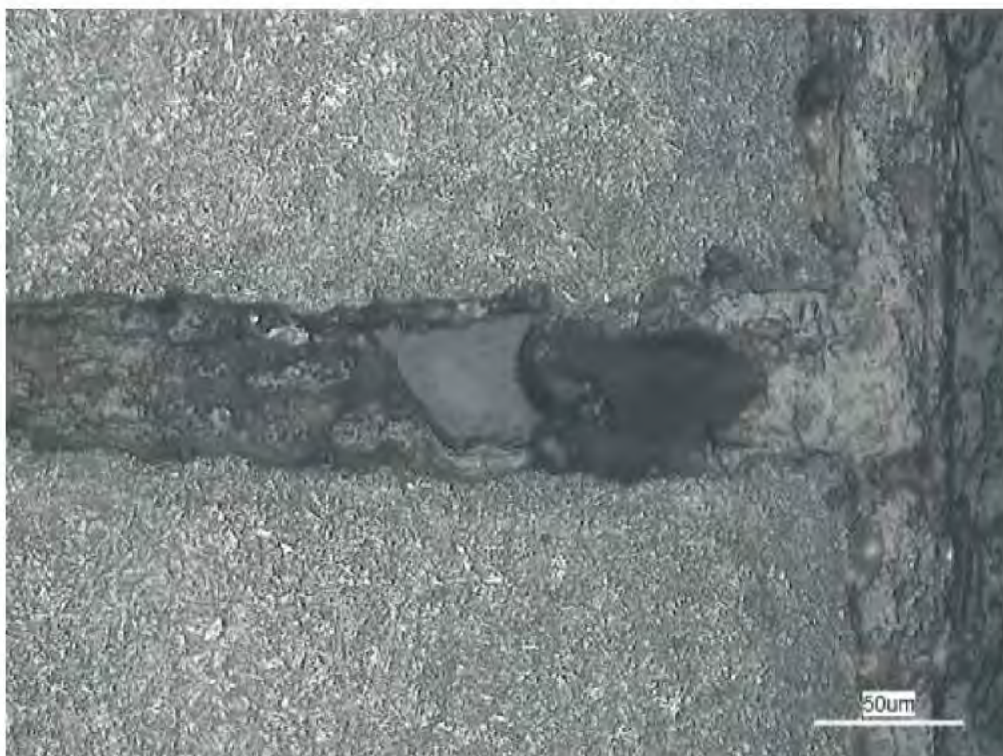
Figure 3.6. Image detailing bolt surface behind the fracture. Note the presence of corrosion deposit within the “spear-like” crack.

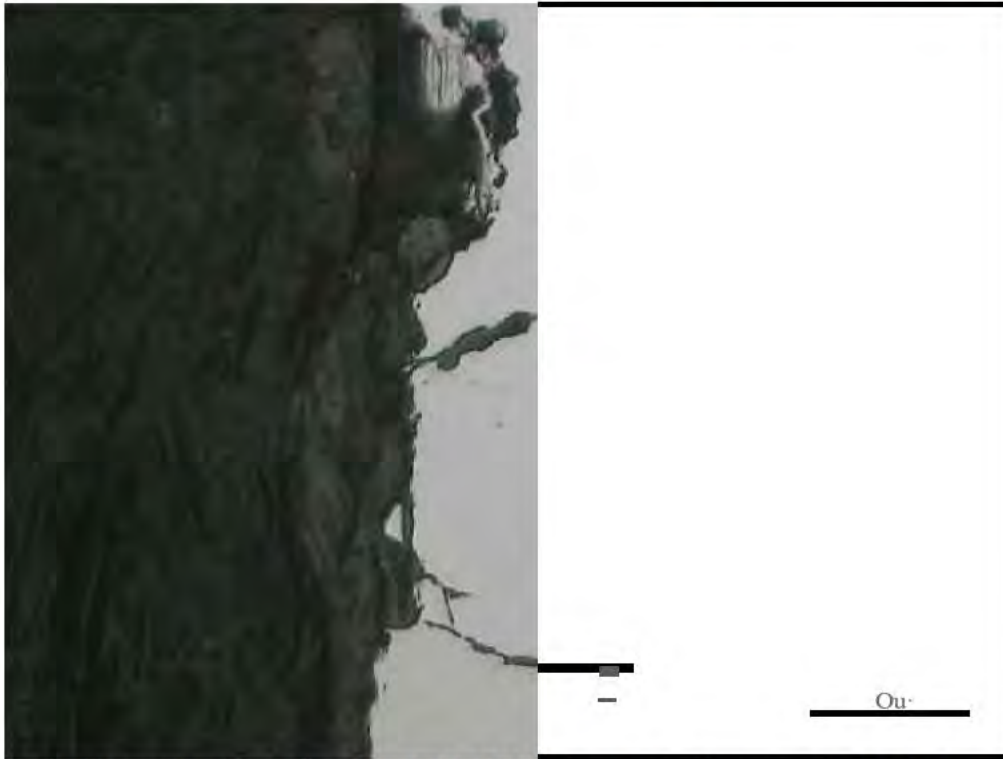
Figure 3.7. Image detailing bolt surface behind the fracture. Note the presence of multiple cracks associated with pitting.

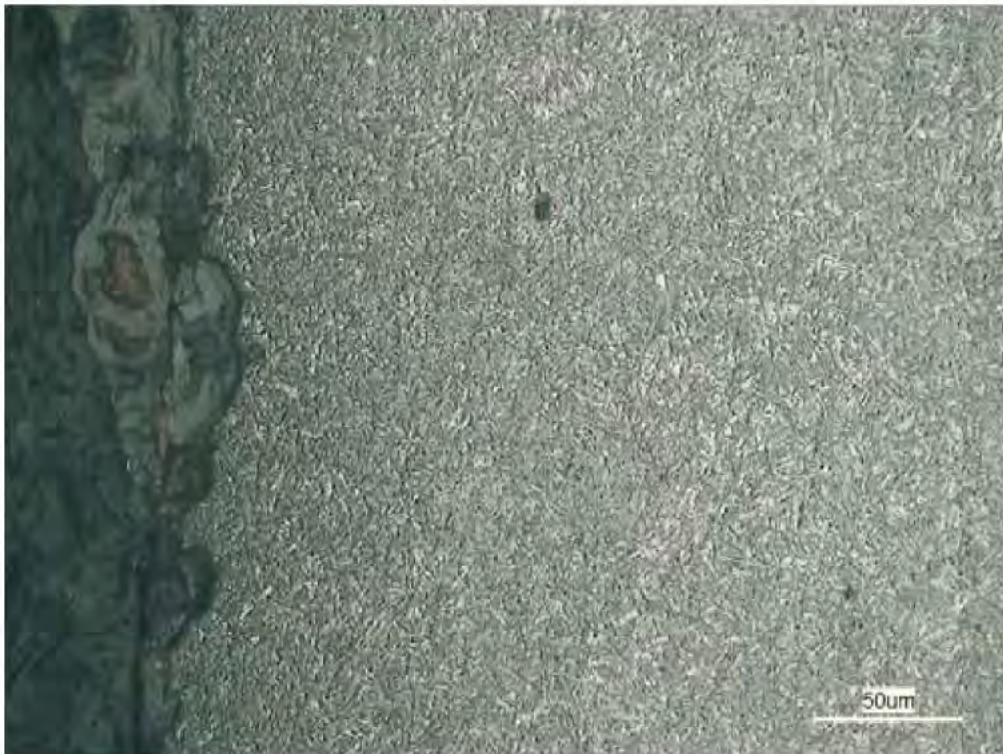
Figure 3.8. Image detailing bolt surface behind the fracture. Note the presence of pitting.

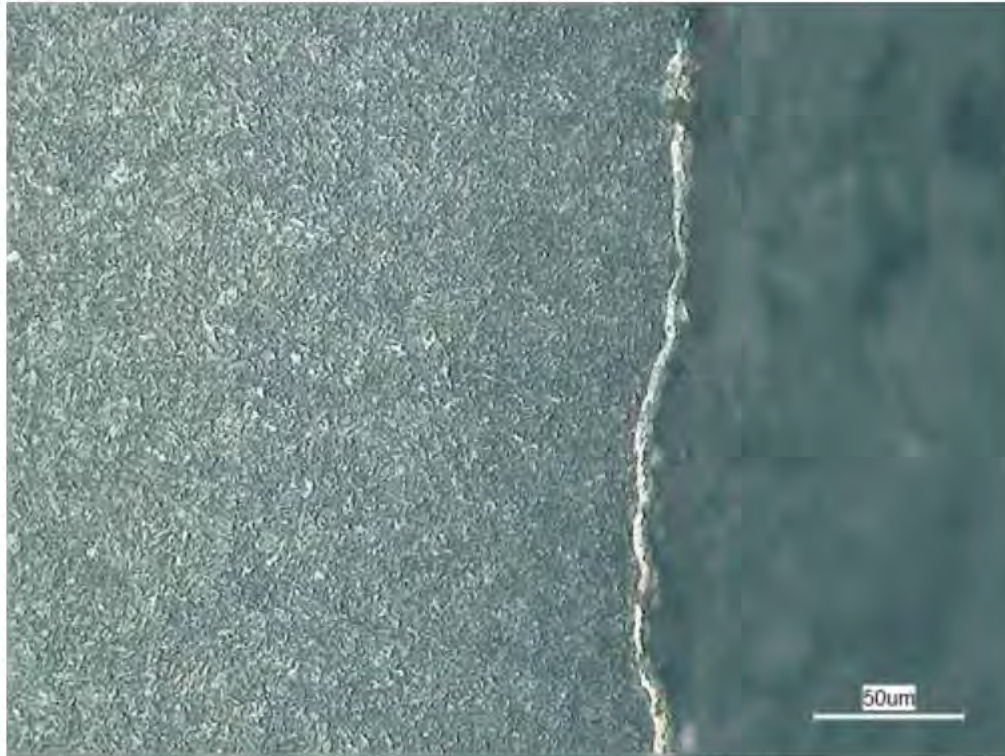
As per Figures 3.9 and 3.10, the general microstructure of for the bolt comprised of quenched and tempered martensite throughout the section, as expected for a class 8.8 bolt. A thin coating/film was evident in areas across the bolt surface, Figure 3.11.

Figure 3.11. Surface of the bolt, detailing a thin coating.

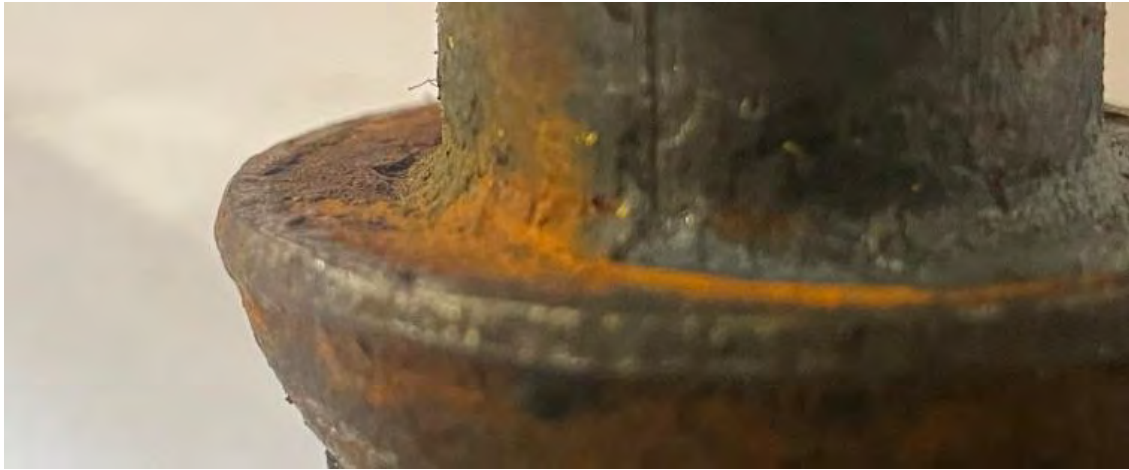
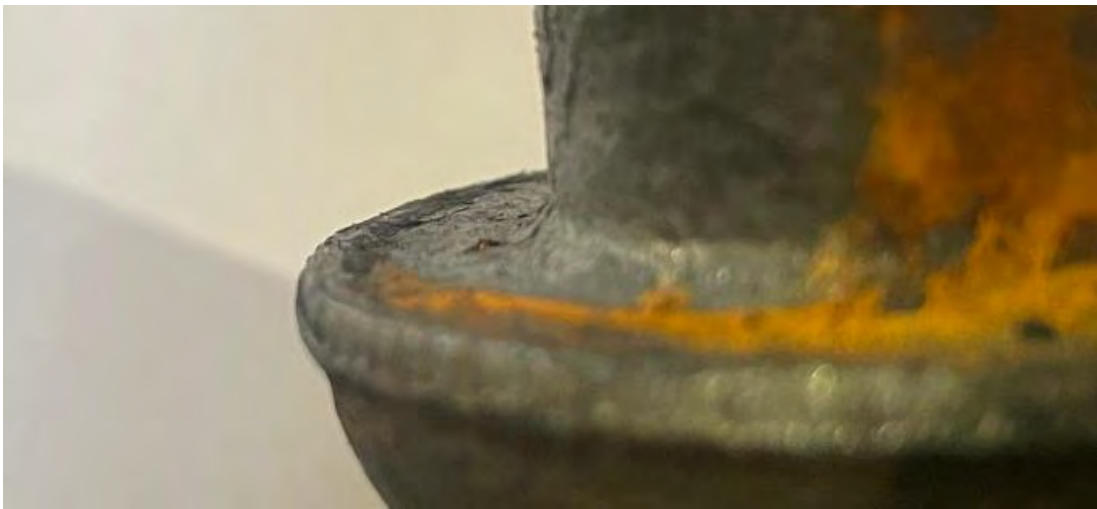
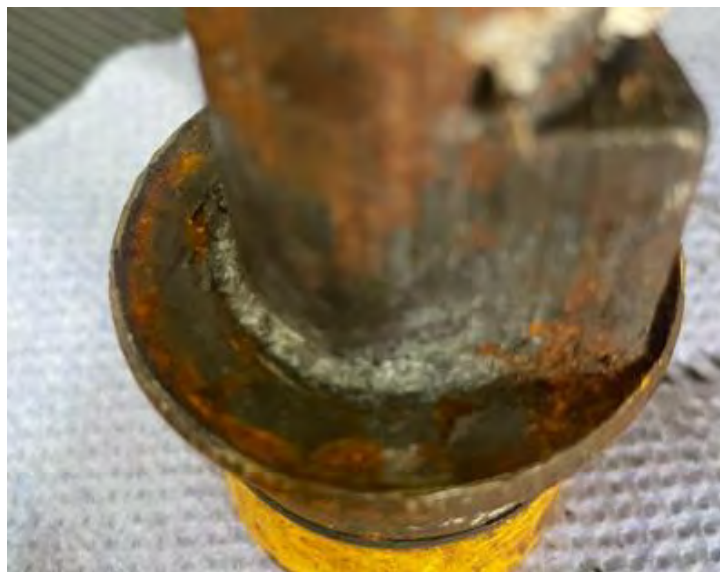
Due to the method in which the head of the imperial pear bolts are forged, a ridge is formed around the outside diameter on the underside of the bolt head. This results in a very small amount of the bolt head area being in contact with the fishplate. Small contact areas will cause point loading, high settling and embedding losses, and large changes in bolt load as the surfaces move due to the fishing action of the plates.

*Figure 1. Underhead condition of imperial bolt.*

*Figure 2. Underhead condition of imperial bolt.*

*Figure 3. Underhead condition of imperial bolt.*

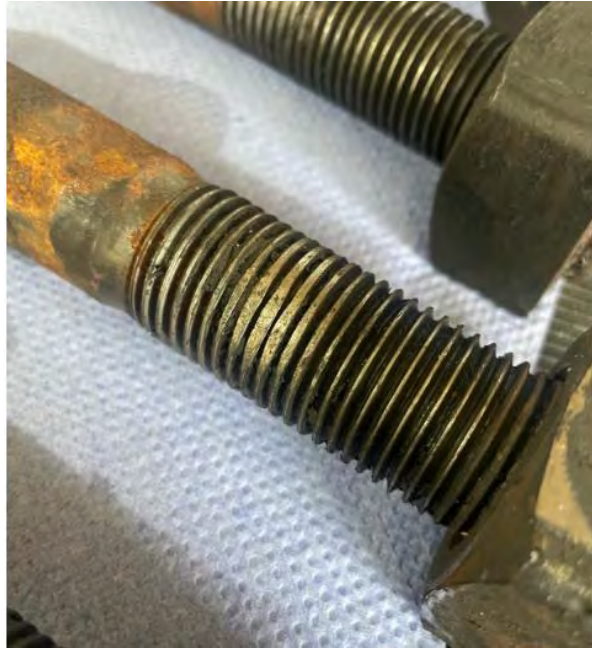
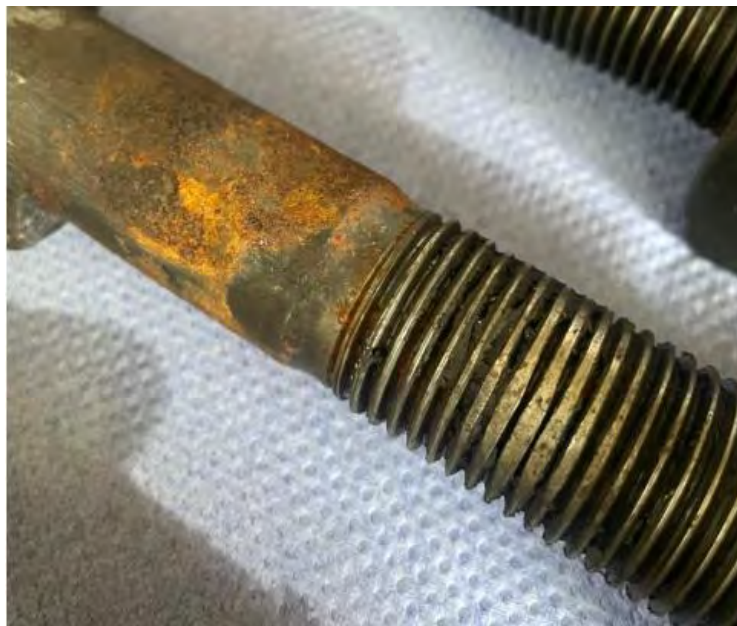
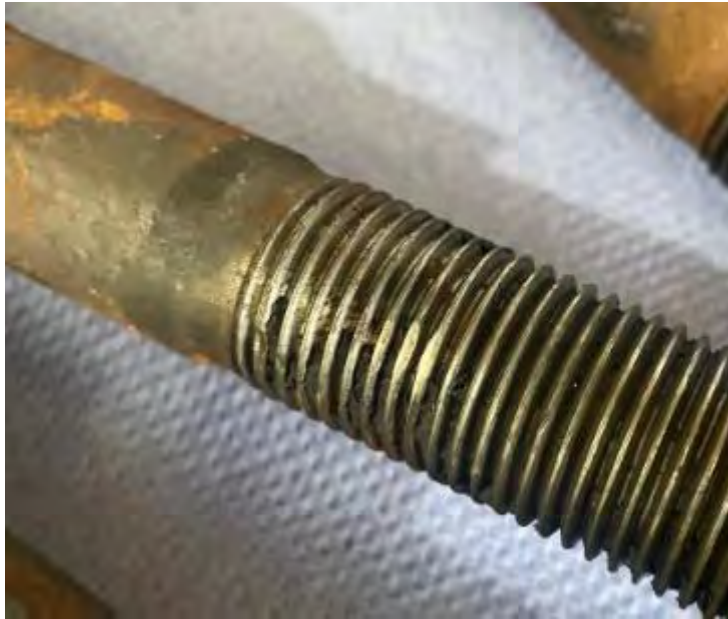
- 3) Threads damaged on imperial bolts. Threads damaged on several of the returned imperial bolts. The damage is still clean indicating it is a recent damage. Either caused by the nut, damage during removal or wear due to plate movement during service. No damage identified on metric bolts.

*Figure 4. Damaged threads on imperial bolt.*

*Figure 5. Damaged threads on imperial bolt.*

*Figure 6. Damaged threads on imperial bolt.*

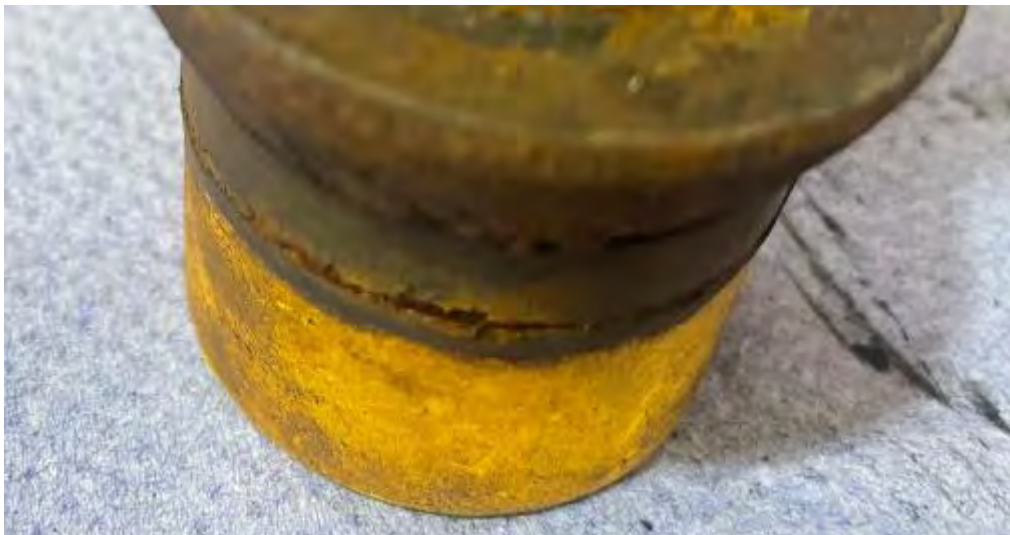
- 4) **M24 bolt 00523 damaged due to use of incorrect tools for device removal.**  
Bolt 00523 still operated correctly but was showing offline from the Tenby site because it was outside the wireless range of the existing mains powered Gateway.  
A ring spanner was wedged against the bolt head and it damaged the end cap during disassembly. A deep socket should be used over the bolt head or a head retaining plate should be fitted.
- 5) **Moisture ingress to end cap.** Four imperial bolts and one metric bolts failed and were showing as 'offline' due to moisture ingress into the end cap. This is caused by corrosion to the bolt and/or the collar (same material and not coated like the bolts). These components should be coated going forwards.

*Figure 7. Bolt corrosion leading to seal failure and moisture ingress.*

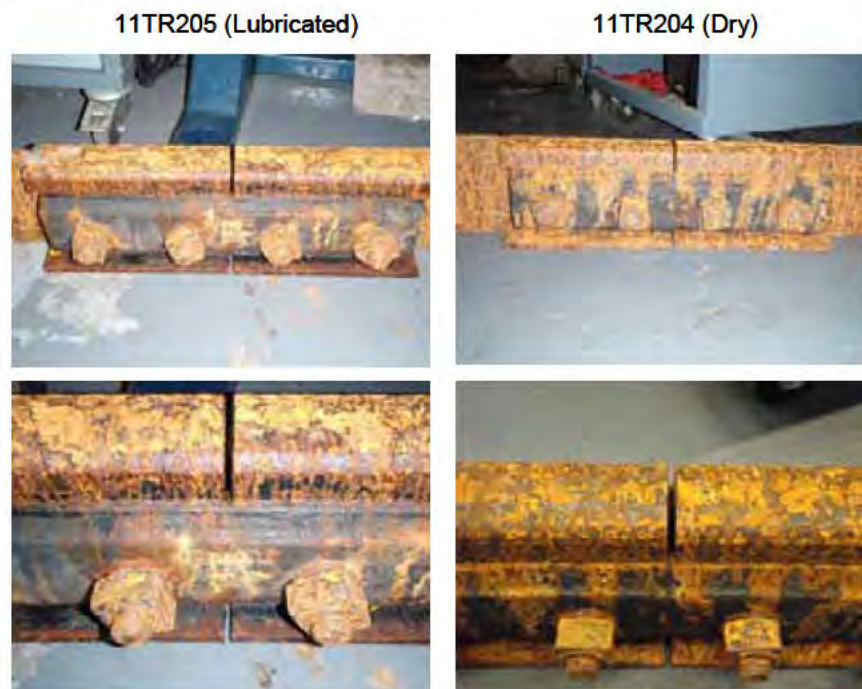
**Figure 4: The two fishplate joints after corrosion for 150 hours**
