**12 Month Report:**  
**Intelligent Bolt Trials for Fishplates & Temporary Clamps**

| Project: | E0102 v3 |
| Document ref: | 12 Month Report -<br>December 2024 |

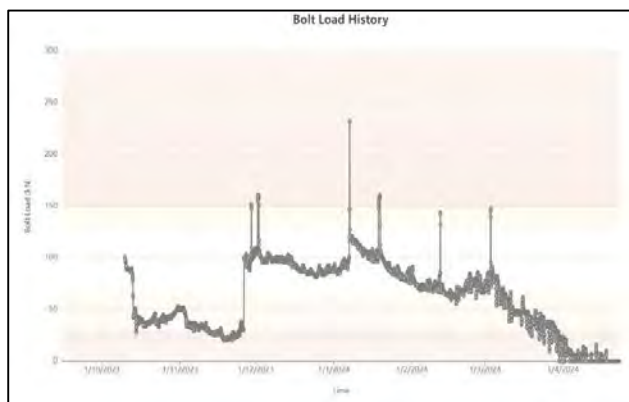
**Imperial bolt with standard fastener**  
*Large variability in clamp load makes prediction difficult*

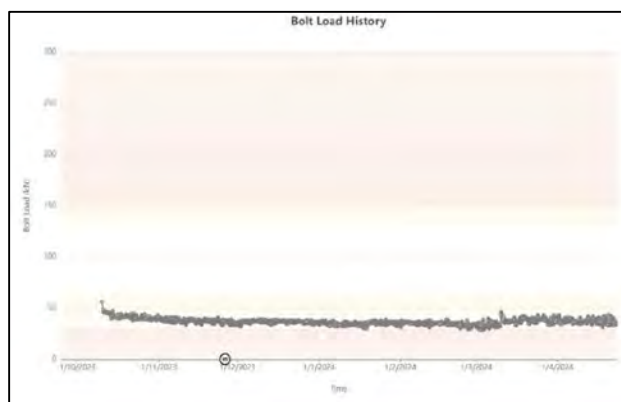
**Metric bolt with Hardlock Nut**  
 Consistency of clamp load makes prediction possible

Once joints are converted to metric bolts with Hardlock Nuts, data shows that there is now an even distribution of clamp force across the whole joint, which improves joint integrity and eliminate spot loading and / or potential bending forces on the fishplates. This should remove the risk of lateral fatigue cracks and breaks, assuming all other track geometry is within standard.

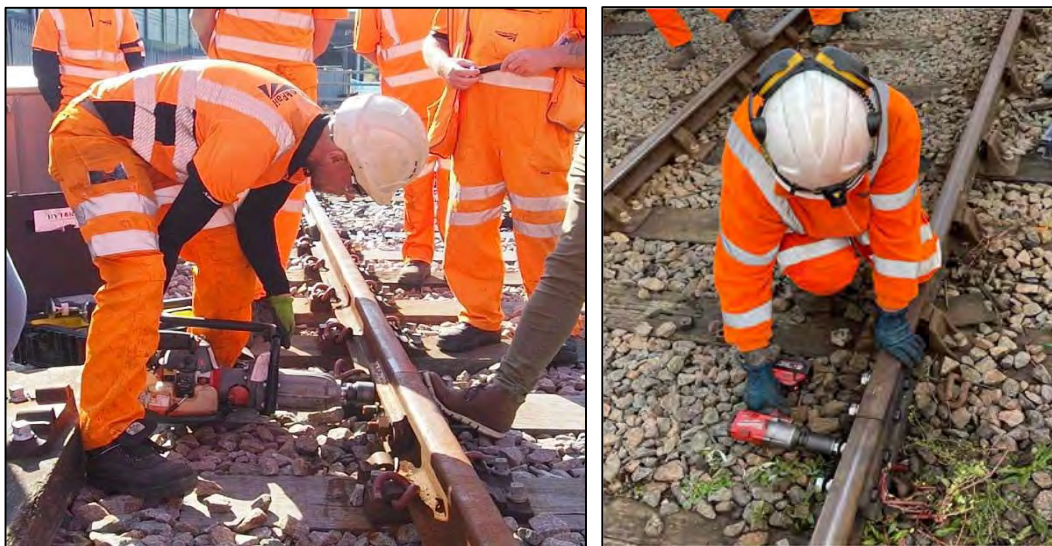
4. Installation process (2,3,4,1) needs to be repeated. Initial clamp force in bolts 2&3 reduces by over 30% when 4&1 are tightened thus leaving a potentially failed joint if only one tightening pass is made.

The current Network Rail work instructions for installing and maintaining fishplate joints require the nuts to be tightened in a specific order, this being nut 2, nut 3, nut 4 and then nut 1. All nuts are tightened in a single pass to the full torque value. The use of the intelligent bolt in track has identified a failure in this process. When nuts 4 and 1 are installed, the clamp force already recorded in the initial assembly drops by over 30%. To remove this failure mode, repeating the process of torque checking in the same order of 2,3,4 & 1 will ensure the joint is left in service in the optimum condition. Note that this applies to both metric and imperial bolts and should be adopted as best-practise.

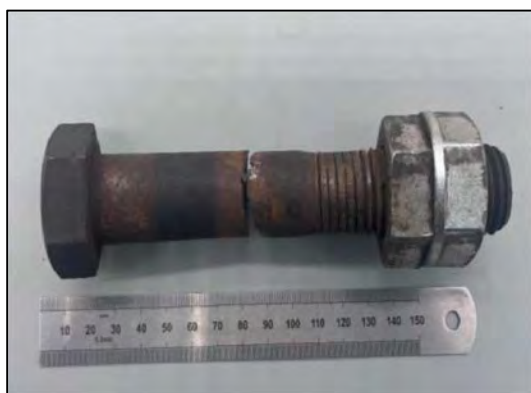
The bolt shown in the photo below failed due to corrosion and not the material quality / specification. The track was also in poor condition where the joint had known dip angle and voiding. This is fully explained in the independent test report included in the Appendices.

As a result of the trial, all new Intelligent bolts will be supplied with a zinc coating. Without any form of corrosion protection, the spread of the corrosion from the bolt head where the Cap is secured has the potential to cause the connection to fail. We have noted this in 4 bolts installed during the trial period.

*Failed metric bolt due to corrosion*

To remove this failure mode Network Rail should consider moving to a zinc plated bolt in line with the finish of the Hardlock Nut ie. an already approved coating. It is worth noting that the cost variance between a self-colour bolt and a zinc plated bolt is comparable. Network Rail tends to store products outdoors, in this scenario there is a high probability of self-colour bolts rusting prior to installation.

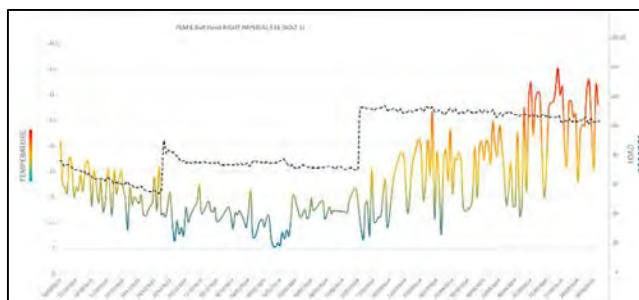
**Imperial**

The intelligent bolt not only records clamp force, but also monitors the internal temperature of the bolt, providing a core temperature rather than just a surface temperature. This offers a more accurate reflection of rail temperature. From the data collected, it has been observed that imperial joints lubricated with RS Clare lubricant generate and retain, on average, approximately 7% more heat.

While it's currently difficult to provide definitive reasons for this heat increase, several factors could contribute. One possibility is that the higher clamp force required for imperial joints generates more heat. Additionally, RS Clare lubricant in this application may create a vacuum effect, which could also necessitate greater force to fish due to seized joints, contributing to the elevated temperatures.

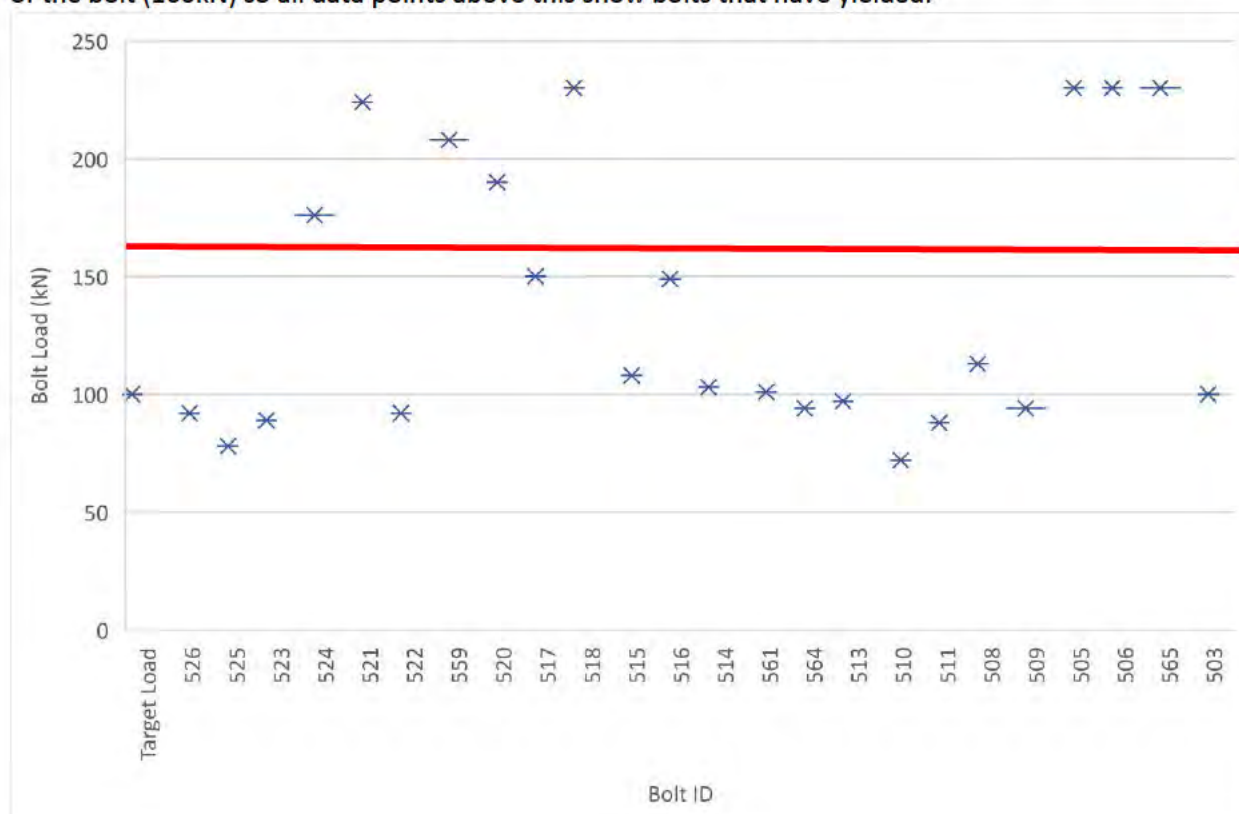
Figure 1. Bolt load achieved at installation IMPERIAL.

The bolt load achieved by the imperial fasteners is highly variable and predominately much higher than estimated for the application (estimate from the technical note on bolt load). A summary of the bolt loads achieved at installation are given in Figure 1 below. The red line denotes the load to yield of the bolt (160kN) so all data points above this show bolts that have yielded.

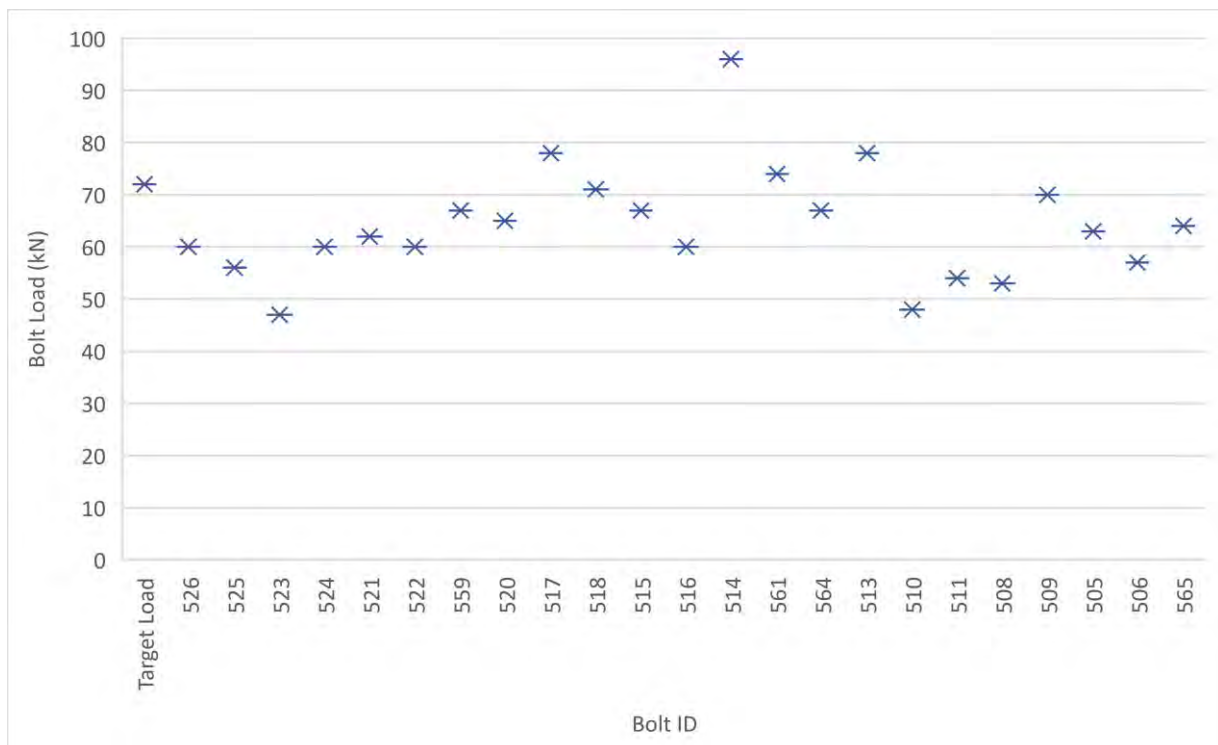
The bolt load achieved by the metric fasteners is much more consistent and predictable than imperial fasteners as seen in Figure 4.

The average bolt load achieved at installation for metric fasteners is less than half that of imperial bolts (average 64kN when compared to 141kN). This is combination of using a different installation torque and the k-factor of the imperial bolts being lower.

Figure 4. Bolt load achieved at installation METRIC.

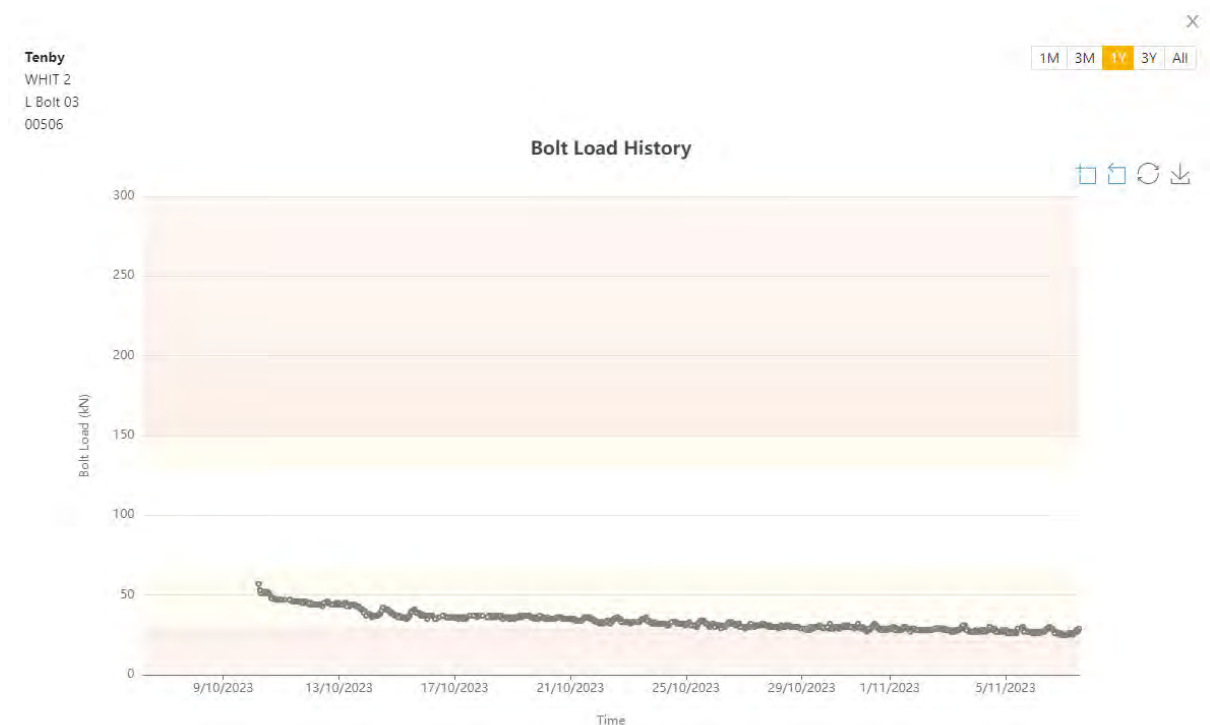
Figure 5. Bolt load over time of metric bolt 00506.

The data is typically characterised by an embedding and settling loss of approximately 15-25kN over the first 72 hrs of operation and then a relatively steady bolt load.

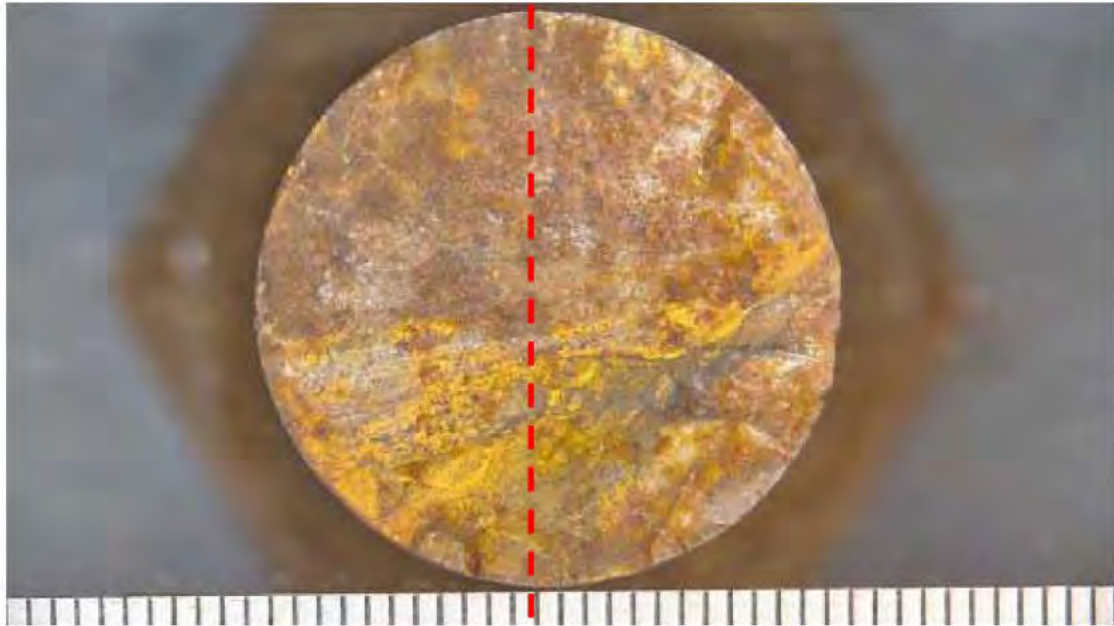
Figure 3.1. Section taken through fracture surface.

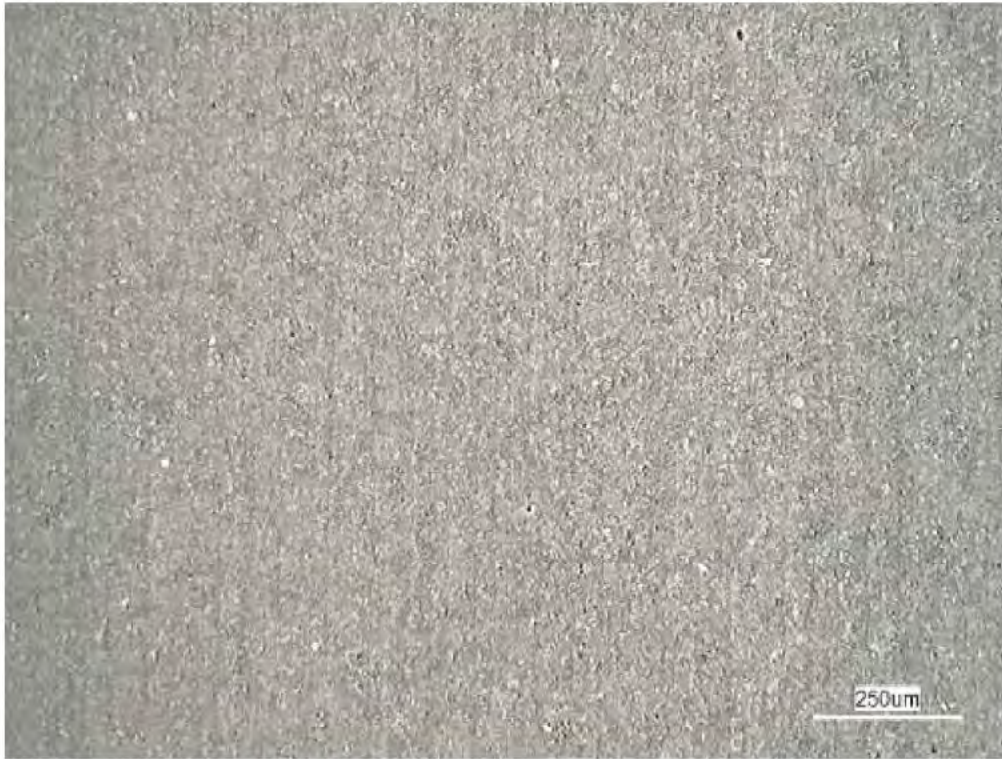
As per Figures 3.9 and 3.10, the general microstructure of for the bolt comprised of quenched and tempered martensite throughout the section, as expected for a class 8.8 bolt. A thin coating/film was evident in areas across the bolt surface, Figure 3.11.

**Figure 3.9. General microstructure of bolt x140.**

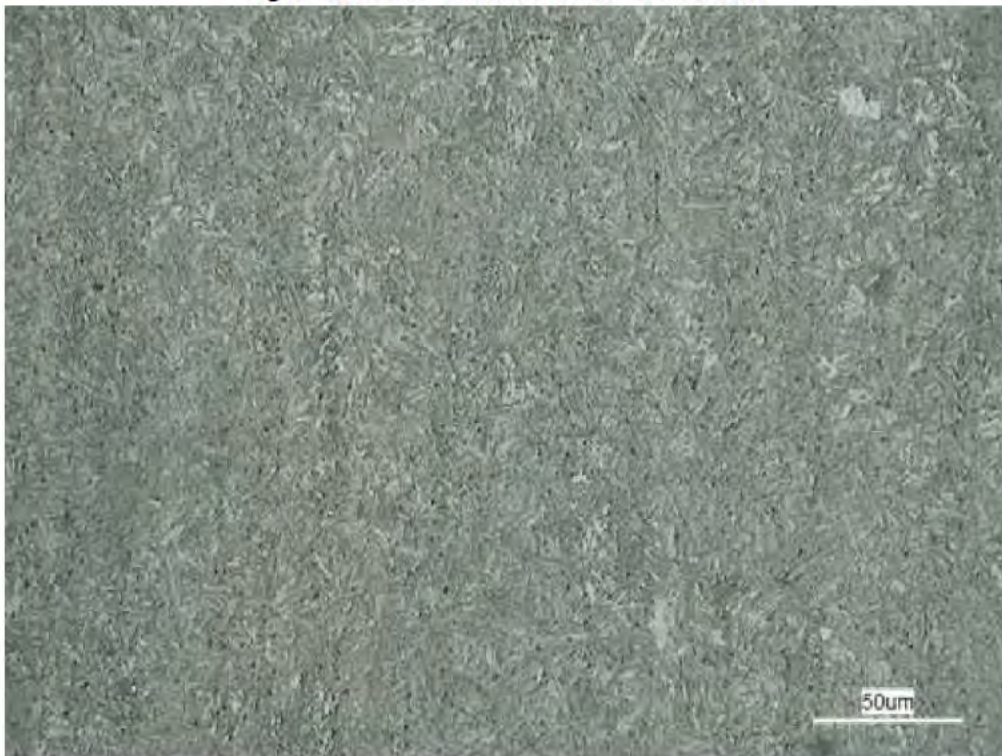
**Figure 3.10. General microstructure of the bolt x700.**

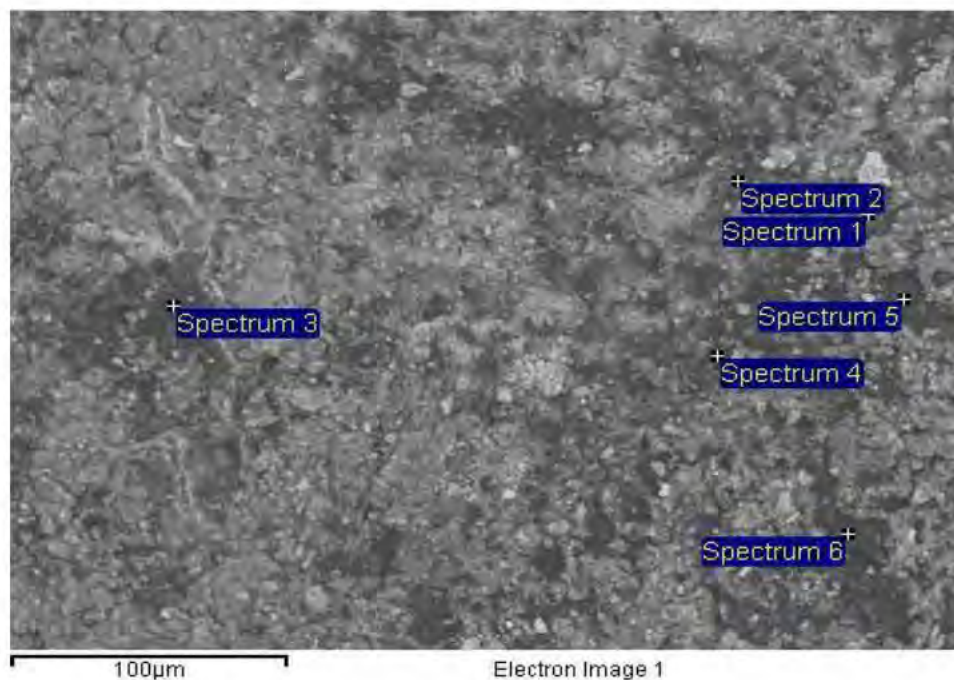
EDX analysis for all locations revealed a composition predominantly comprised of iron and oxygen, with small amounts of phosphorus, barium, potassium, calcium, sulphur, chlorine and sodium. Isolated areas contained significant amounts of cobalt and tungsten, the origin of which is not clear.

Figure 5.1. Image detailing bolt surface: showing areas analysed.

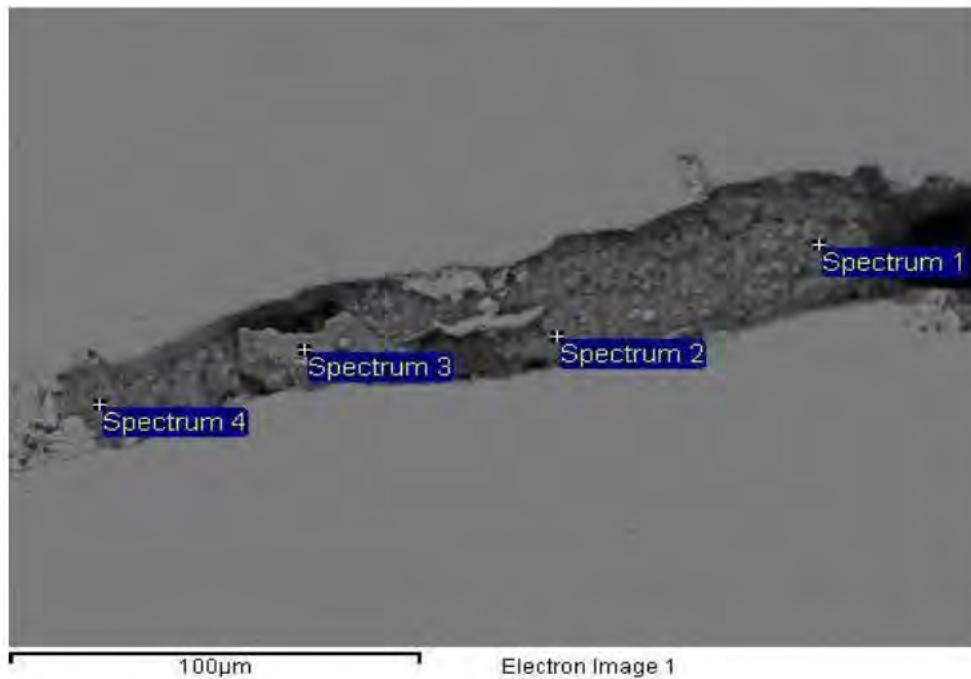
Figure 5.2. Image detailing spear like crack corrosion: showing areas analysed.

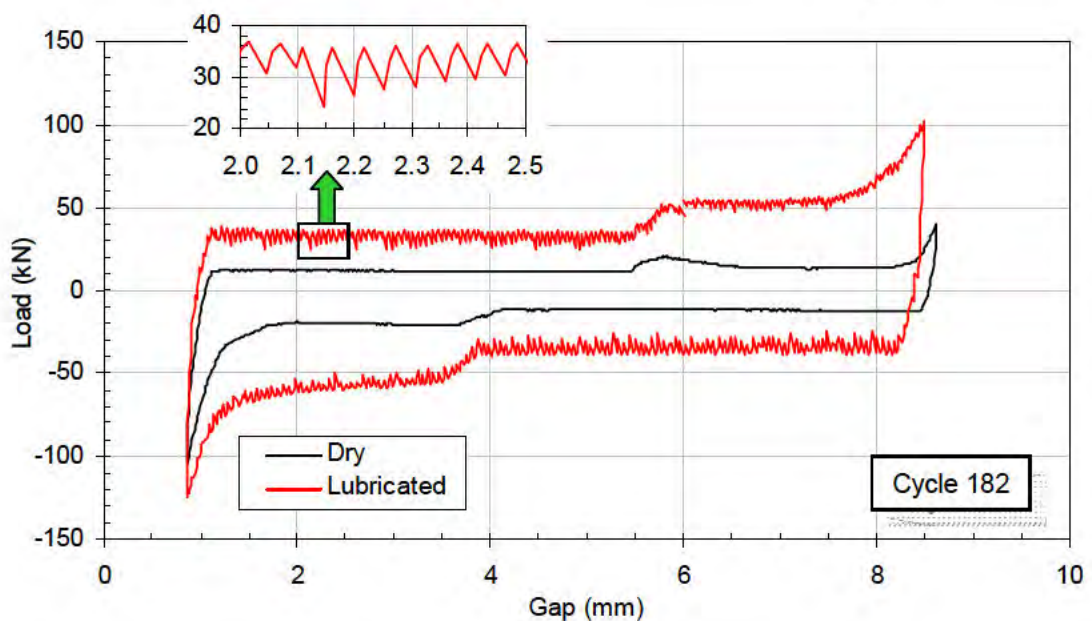
After both fishplates had been subjected to 150 hours in a corrosive environment, they were reloaded into the test rig for a further 4 cycles (cumulative cycle numbers 181-184). The load vs. displacement graph corresponding to the second cycle after corrosion is shown in Figure 9. The lubricated fishplate joint exhibited a clear 'serrated' load vs. displacement trace with the load oscillating over a range of approximately 10-15kN. This effect was also evident, but to a lesser extent, prior to corrosion where the oscillations in load were of the order of 2kN (bottom right of Figure 5). For the purposes of calculating the value of the load plateau, an averaged load was calculated through these oscillations.

**Figure 9: Load vs. displacement behaviour on the 2<sup>nd</sup> cycle after corrosion (cumulative cycle 182)**

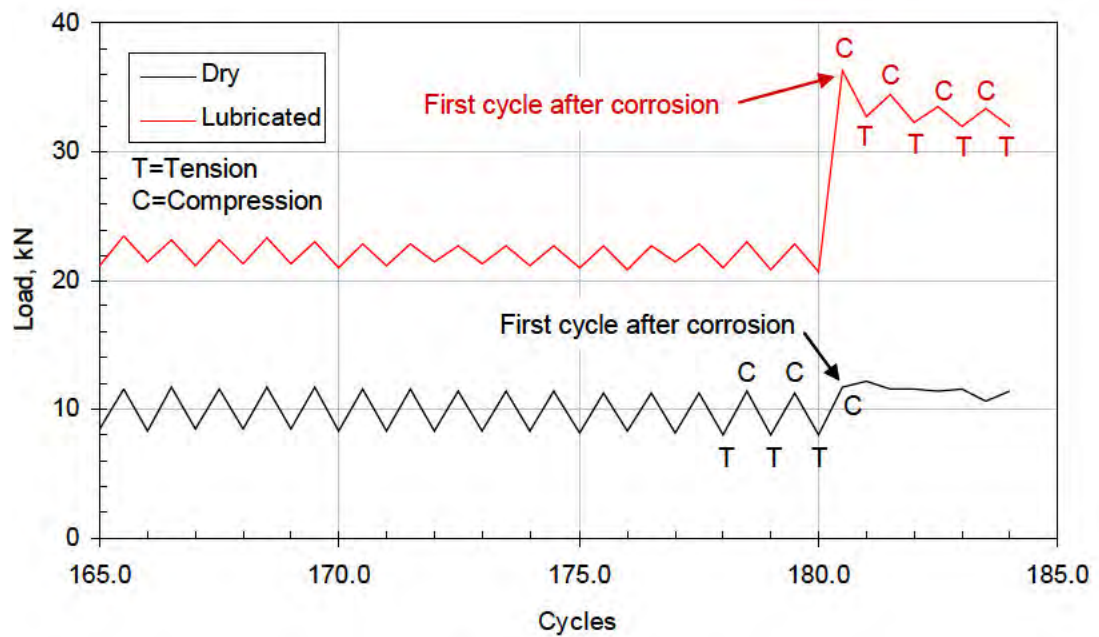
Figure 10 shows the value of the averaged load plateau plotted as a function of cumulative cycle number. There is a clear effect of corrosion on the load required to move the rails in the lubricated fishplate specimen: the required load increased by around 60% when comparing tension-to-tension (or compression-to-compression) parts of the cycle.

**Figure 10: Load vs. cycle number following corrosion**

The effect of corrosion on the dry specimen was less significant. The compressive loads required to move the rails were very similar after corrosion to the loads required prior to corrosion. The difference between the tension and compression cycles was reduced following corrosion, with no clear zig-zag pattern visible in Figure 10.

The results in Figure 10 indicate that corrosion has a bigger effect on the lubricated fishplate specimen than the dry specimen. Although it is difficult to draw firm conclusions on the basis of two tests, a potential explanation could be that the effects of corrosion were able to penetrate more deeply into the lubricated fishplate specimen if the two fishing surfaces were slightly apart from each other due to the presence of RS Clare All-Seasons P-Way Lubricant. Some evidence to support this is in the corrosion tests for sample RS Clare All Seasons Pway Lurbicant seeing some corrosion at edges.

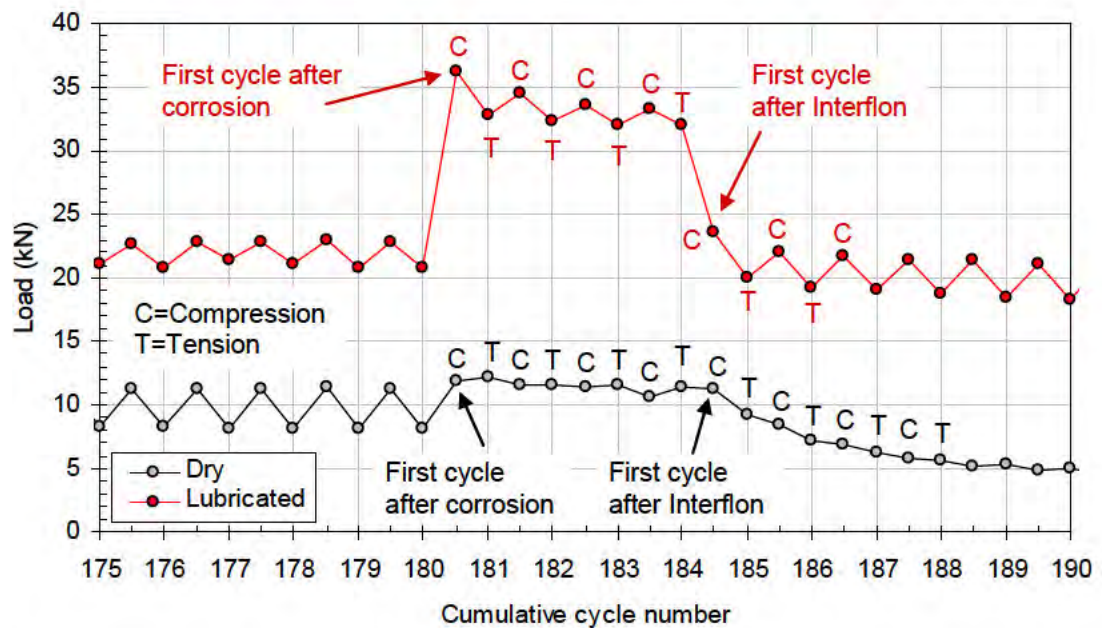
Figure 12 shows the value of the averaged load plateau plotted as a function of cumulative cycle number. The Interflon spray had a significant effect on the loads measured on both the lubricated and dry fishplate. The loads required to move the rails in the lubricated fishplate reduced significantly immediately after spraying, returning back to pre-corrosion levels. However, additional cycles had no further significant effect on the load which remained around 20kN. For the dry fishplate there was a more gradual effect and the load reduced by around 75% in the first 10 cycles after application. After 256 cumulative cycles the load was just 1kN.

The results indicate that Interflon did not have a significant effect on the difference between tension and compressive loads. The dry fishplate showed no clear difference between the tension and compression cycles both before and after spraying with Interflon. The lubricated specimen, which did show a clear difference between the tension and compression cycles, did so both before and after spraying with Interflon.

**Figure 12: Load vs. cycle number immediately after application of Interflon**

The results in Figure 12 suggest that after corrosion the differences between tensile and compressive load almost disappear for the dry fishplate specimen. It is important to note,

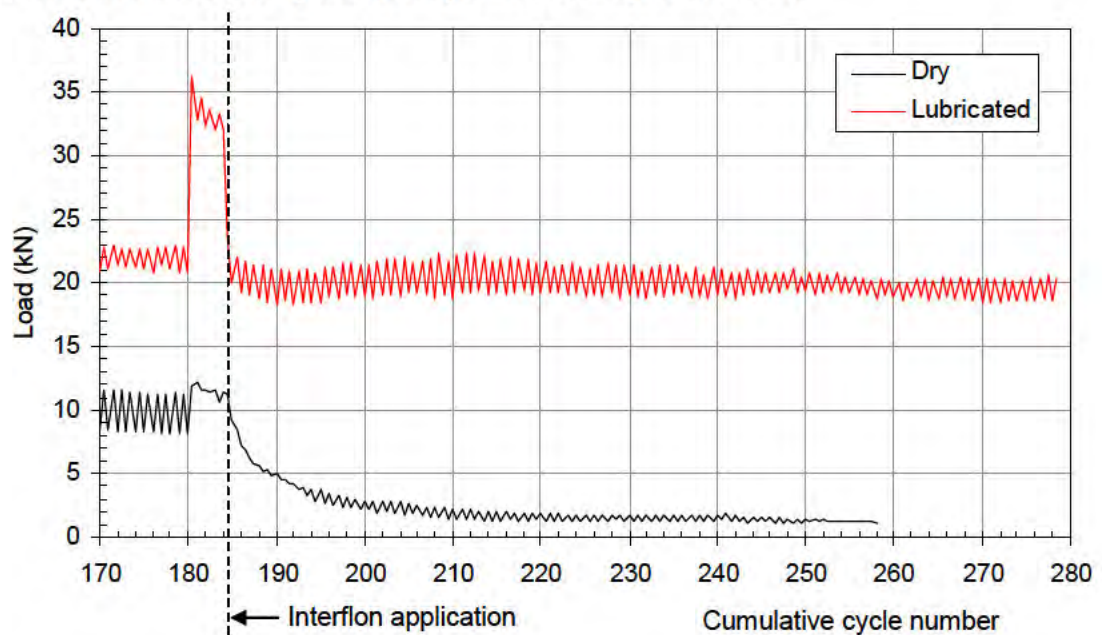
Figure 13 shows the load vs. cycle number for the 70-90 cycles applied after Interflon (cumulative cycle numbers 185-260). The load on the lubricated fishplate significantly reduced in immediately after the Interflon application, thereafter the load remained constant. The dry fishplate resulted in a very low load of only 1.2kN after 258 cumulative cycles. For the dry fishplate, over 80% of the load reduction following Interflon application occurred in the first ten cycles (i.e. by cumulative cycle no. 195).

**Figure 13: Load vs. cycle after the application of Interflon**

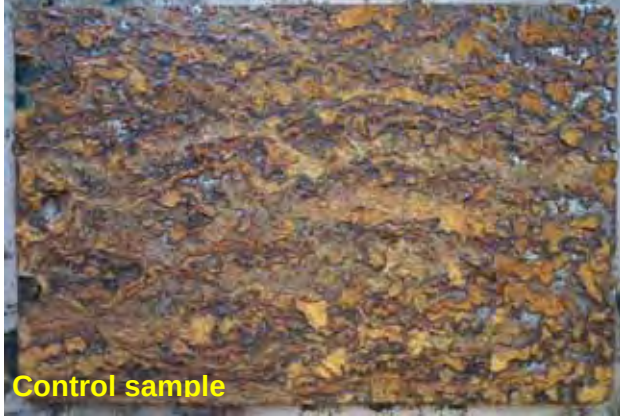
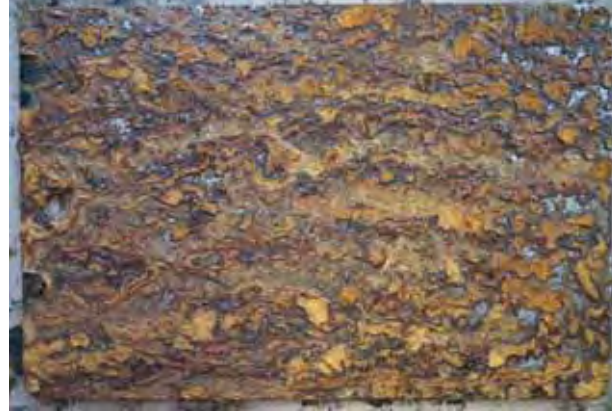
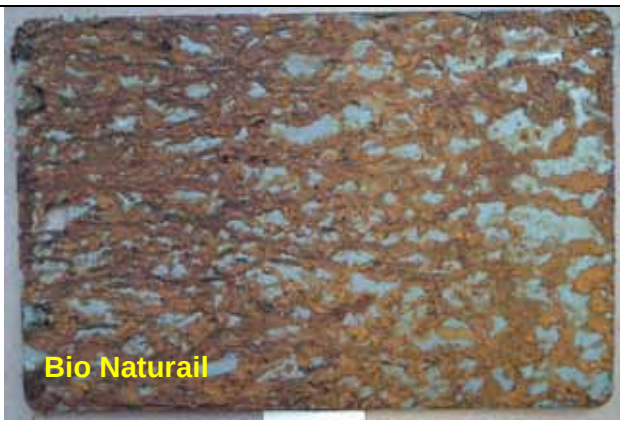
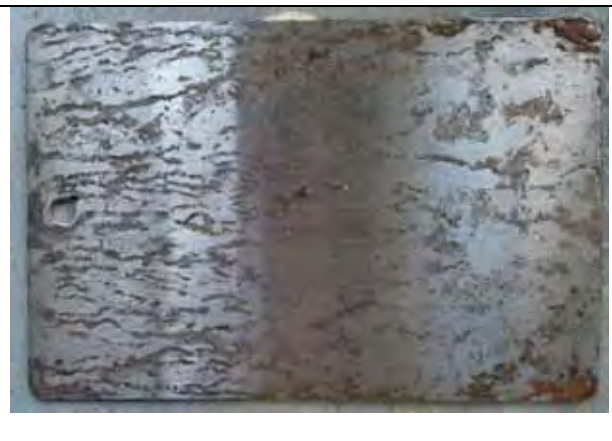
As show in the images above all the lubricants are generally performing well in all but two cases, Finlube (interflon) and XL fishplate oil where it is shown that after cleaning with Methyl Ethyl Ketone the corrosion has worked through on to the surface of the metal. In both cases, the lubricant used was low viscosity, which could mean that during the preparation of the samples the lubricant may have run off to leave a layer of lubricant too thin to offer a sufficient protection against corrosion.

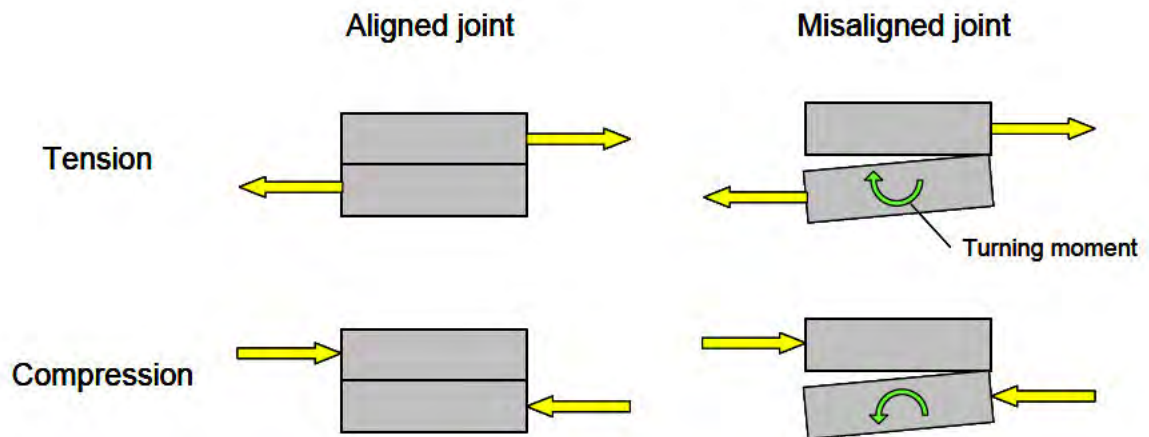
Another effect seen throughout most of the tests is a difference between the load plateaus in tension and compression. Where a difference is observed, the compressive load is always slightly higher than the tensile load. A potential cause of this difference may be some form of misalignment within the fishplate. Figure 14 is a schematic showing how tension and compression may lead to differences in measured load via this mechanism: tensile loading would tend to straighten out a misaligned joint by creating a turning moment, which tends to reduce the load (top right of Figure 14). The same misaligned joint loaded in compression would be subjected to a turning moment in the opposite direction, which would tend to increase the measured load (bottom right of Figure 14). For a perfectly aligned joint no difference would be expected between tension and compression.

**Figure 14: Schematic showing how a misaligned joint could produce differences in load between tension and compression**

When attempting to measure the load relevant for track buckling, the higher compressive load would be the relevant load to consider. However, a test designed to differentiate between different lubricants may be more effective if only the tensile load were considered, assuming the idea in Figure 14 is correct. This is because the compressive load plateau in the test is a function of both misalignment and friction, whereas the tensile load plateau is a function of friction only. It is recommended further consideration is given to the differences between the tension and compression loads in the proposed Phase 2 test programme.
